## SUMMARY

Ron Long  
Master Inspector  
Integrated Home and Environmental  
Inspections  
720-916-6829  
[ron@integratedinspections.org](mailto:ron@integratedinspections.org)

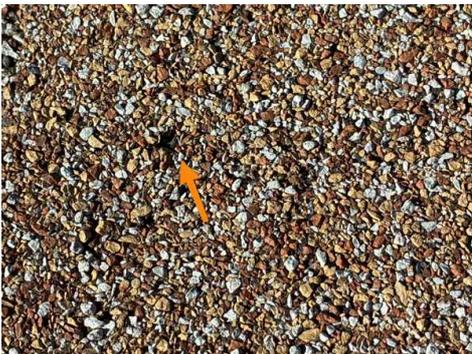
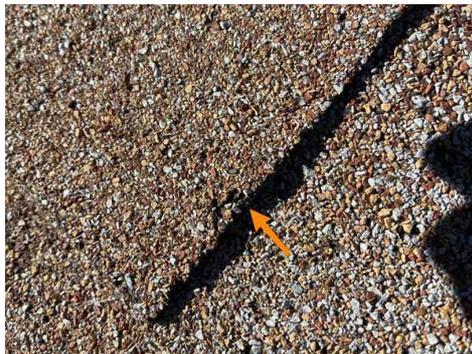
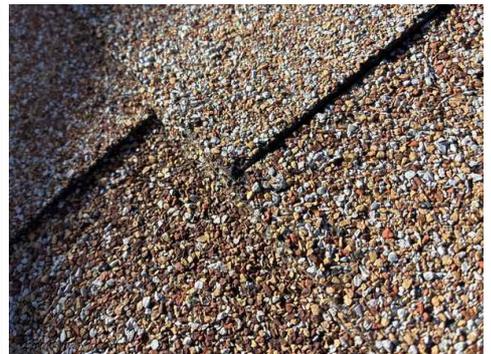
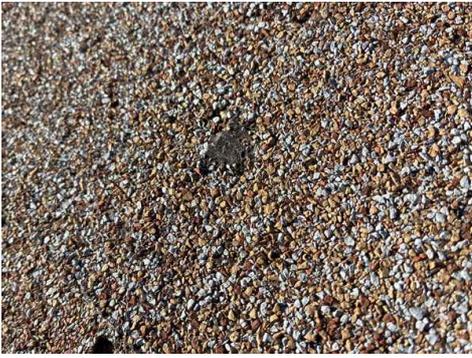
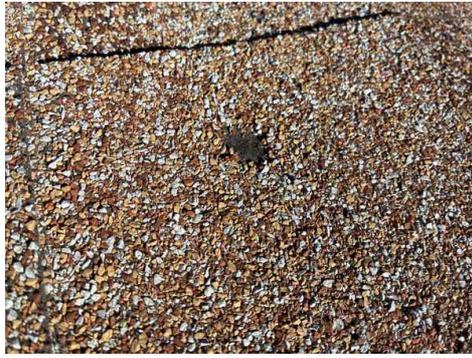
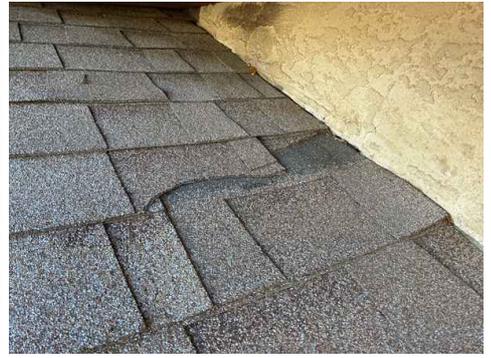
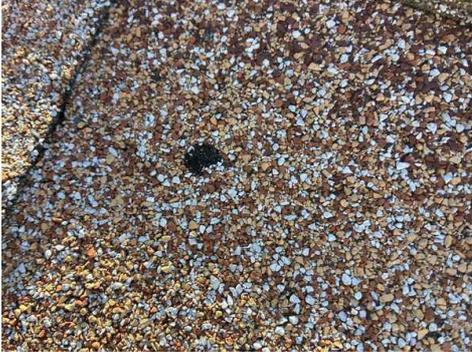
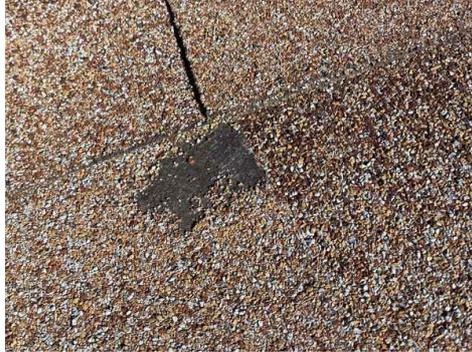
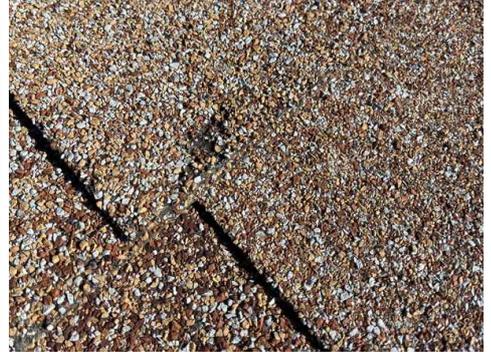
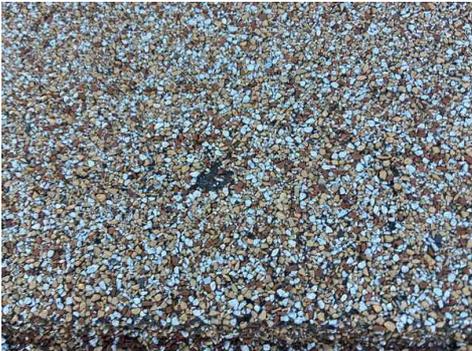
### 3.2.1 Roof Covering

#### DAMAGED/DETERIORATED

The roof covering material was damaged/deteriorated in some areas. A qualified contractor should evaluate and repair or replace as necessary.

Contact a qualified professional.

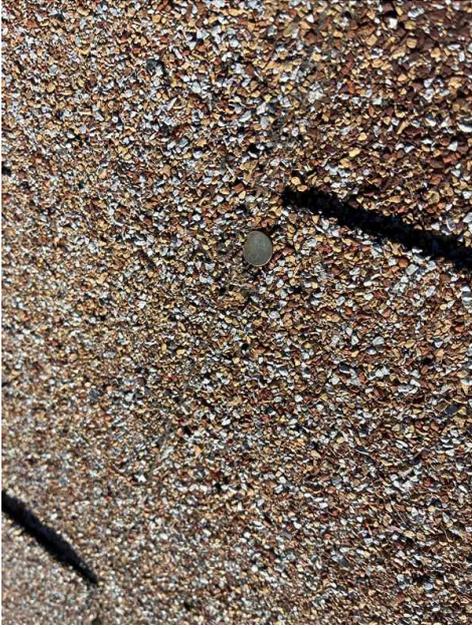
### 3.2.2 Roof Covering

#### **EXPOSED NAILS**

The roof covering had exposed nails multiple areas. Recommend a qualified contractor evaluate to seal the nail head openings or make general repairs or replacement as necessary.

Recommendation  
Contact a qualified professional.

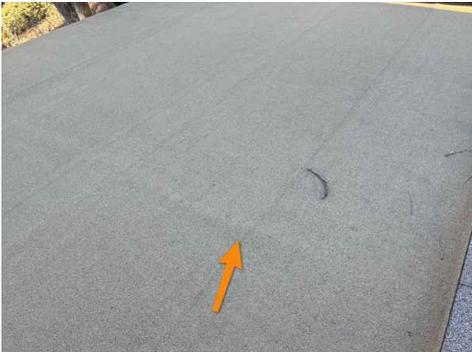
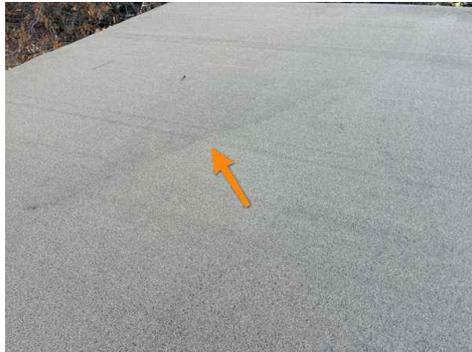
### 3.2.3 Roof Covering **BULGING/BUBBLING**

The roof covering is bulged or bubbled in some areas, which may make it more susceptible to damage. Recommend a qualified contractor evaluate and repair or replace as necessary.

Recommendation  
Contact a qualified professional.

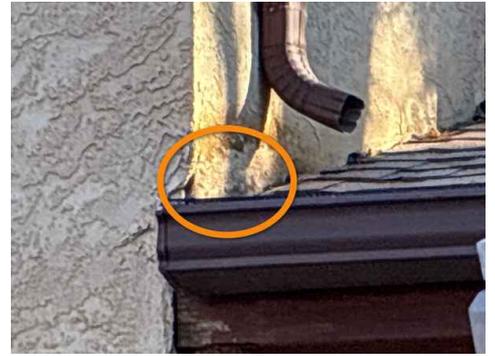
### 3.4.2 Flashing

## KICK-OUT FLASHING MISSING

Wall flashing was missing kick-out or diverter flashing, which is needed where a wall extends past a roof edge. This may allow moisture intrusion of the exterior walls. A qualified contractor should evaluate and repair or replace as necessary.

Contact a qualified roofing professional.

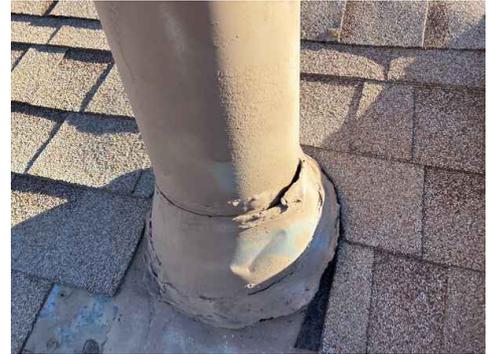
### 3.6.1 Flue Gas Vent Pipes

## FLASHING NOT SEALED

One or more combustion appliance exhaust flue(s) were not sealed at the flashing properly. A qualified contractor should evaluate and repair/replace as necessary.

Contact a qualified roofing professional.

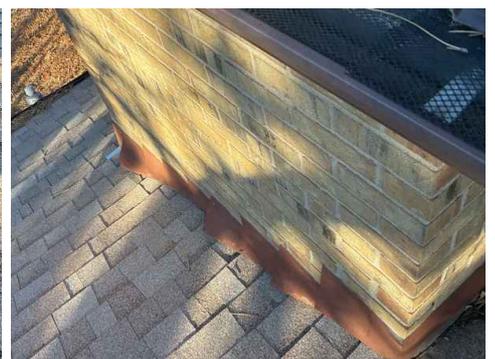
### 3.8.1 Masonry Chimney

## DAMAGE - FLASHING

The chimney flashing was bent, corroded, loose, or otherwise damaged at the time of inspection. Water is prone to leaking at this area when flashing is not in serviceable condition.

A qualified contractor should evaluate and repair or replace as necessary.

Contact a qualified chimney contractor.

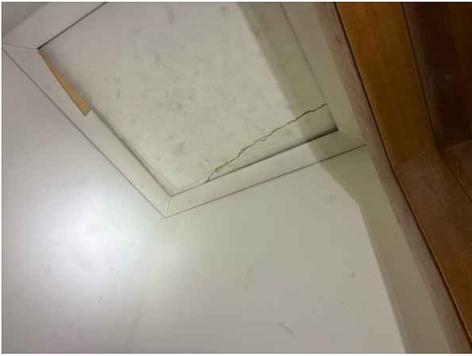
## DAMAGED HATCH

The attic access hatch was damaged. A qualified contractor should evaluate and repair or replace as necessary.

Contact a qualified professional.

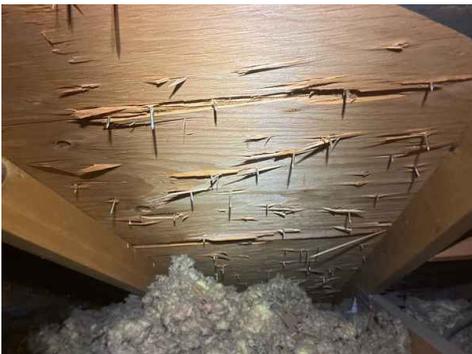
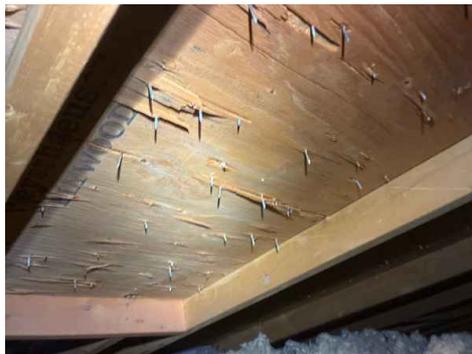
4.2.1 Attic Structural Components

**ROOF DECKING DAMAGED/ALTERED**

The roof decking had been damaged or altered. This can affect the overall structural integrity of the roof, and cause the roof to sag or fail in that area.

Trusses are specifically engineered and designed to support the roof and loads placed on it, such as snow. The individual components of a truss -- webs, connectors, gusset plates, straps, clips, and fasteners -- and all trusses in a roof are designed to perform together as a system. Recommend further evaluation by a licensed roofing contractor and/or structural engineer to determine the effect of the damage or alterations, and options for any necessary repairs.

Recommendation  
Contact a qualified carpenter.

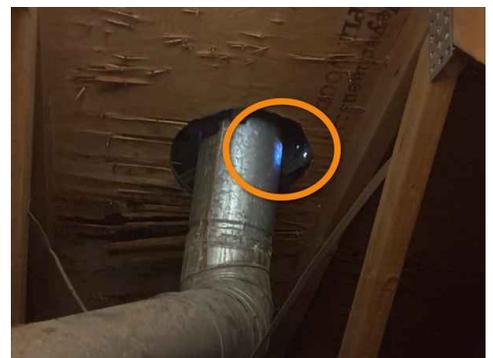
Daylight was noticed. This can allow moisture intrusion into the attic and cause mold. There were no visible signs of mold at the time of inspection. A qualified contractor should evaluate and correct.

Recommendation  
Contact a qualified professional.

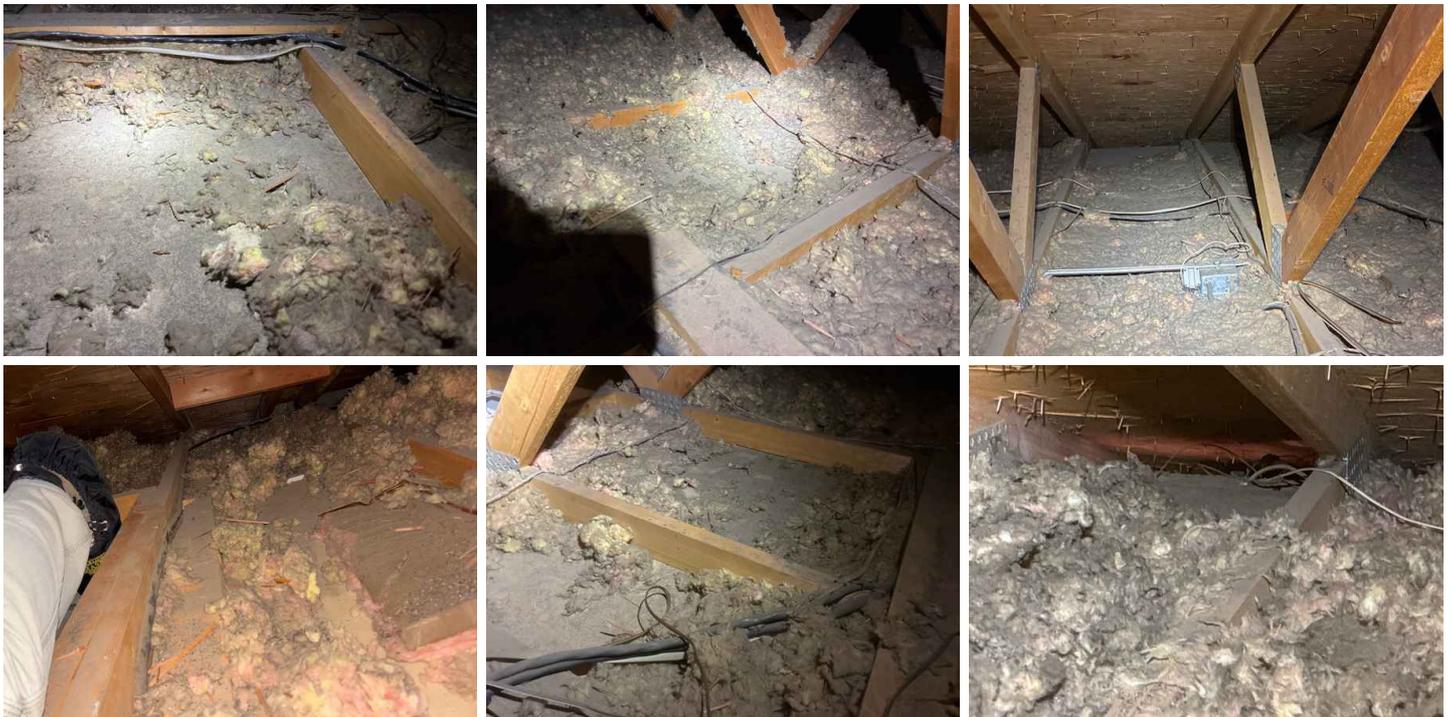
#### 4.4.1 Insulation in Attic **MISSING - INSULATION**

The insulation is missing in areas of the attic. Adding insulation will greatly improve the home's energy efficiency. Recommend a qualified contractor evaluate and add insulation as necessary to achieve current R-Value requirements.

Contact a qualified professional.

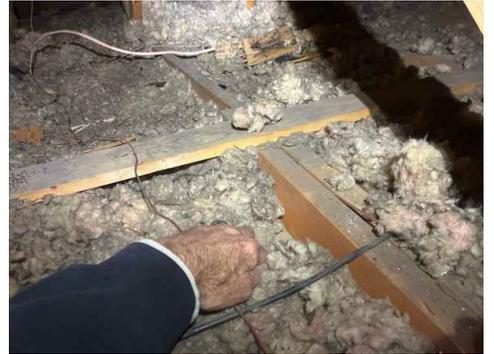
## 4.4.2 Insulation in Attic

**ATTIC INSULATION - THINNER THAN CURRENT STANDARDS**

Recommend a qualified contractor to evaluate and add more insulation as needed.

Contact a qualified professional.

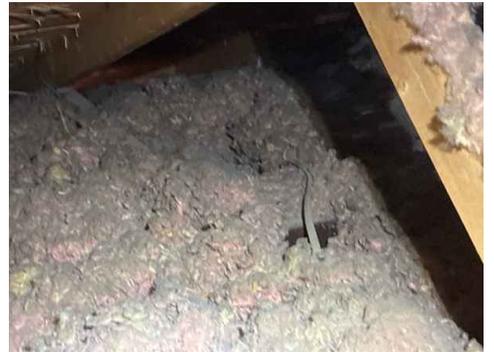
## 4.7.1 Exhaust System Vents

**BATHROOM FAN EXHAUSTS INTO ATTIC**

A bathroom vent duct terminated in the attic and did not vent to the exterior of property. Recommend reconfiguring this duct to completely vent to the exterior.

Contact a qualified professional.

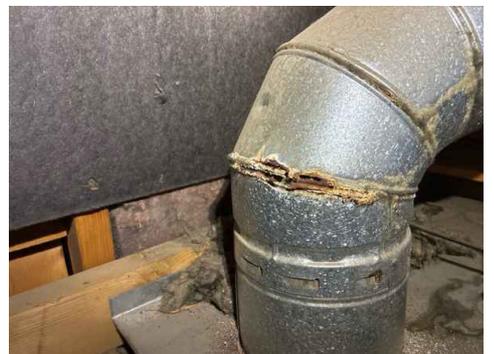
## 4.7.2 Exhaust System Vents

**CORRODED EXHAUST**

The furnace/water heater exhaust was corroded. Carbon monoxide could be allowed to enter the attic/living space. This may also create moisture/mold issues or a possible fire hazard if not corrected.

A qualified contractor should evaluate and repair or replace as needed.

Contact a qualified HVAC professional.

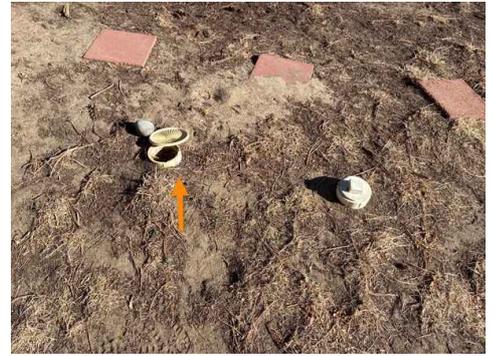
**MISSING CAP**

One of the sewer line caps was missing. This can allow foreign material into the sewer system. A qualified contractor should repair or replace.

Recommendation  
Contact a qualified professional.

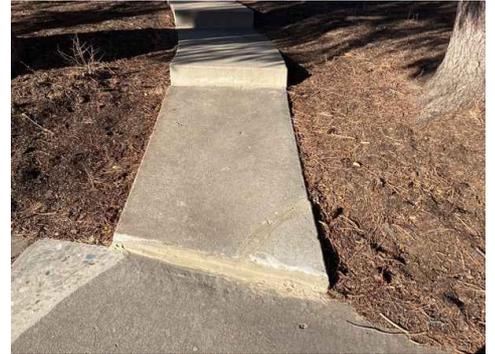
5.2.1 Walkways & Driveways  
**HEAVING AND/OR SETTLING**

The driveway and or walkway showed signs of heaving and/or settling. Heaving is often caused by either soil which has expanded in volume in response to increases in soil moisture content, or by wet soil which has expanded as it has frozen. This is a potential trip hazard, and could result in injury. A qualified contractor should evaluate and repair or replace as necessary and according to current standards.

Recommendation  
Contact a qualified driveway contractor.

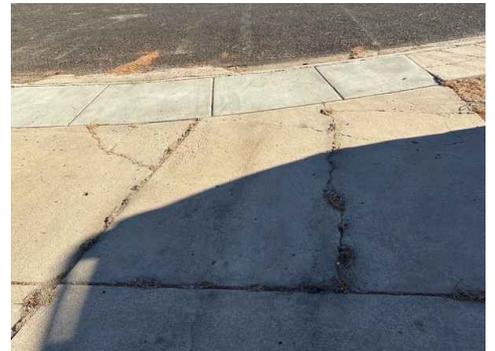
5.2.2 Walkways & Driveways  
**MODERATE CRACKING - DRIVEWAY**

There were signs of moderate cracking at the driveway. Recommend sealing these cracks with an appropriate sealant. A qualified contractor should evaluate and repair or replace as necessary and according to current standards.

Recommendation  
Contact a qualified concrete contractor.

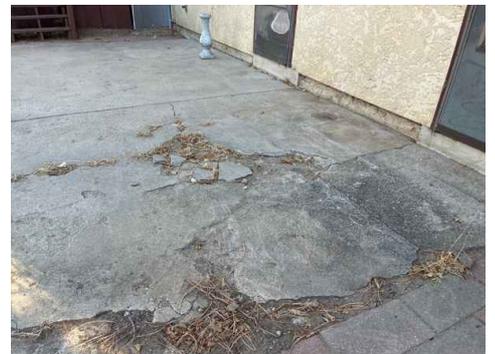
5.2.3 Walkways & Driveways  
**DETERIORATED**

The walkway concrete was deteriorated. A qualified contractor should evaluate and repair or replace as necessary and according to current standards.

Recommendation  
Contact a qualified concrete contractor.

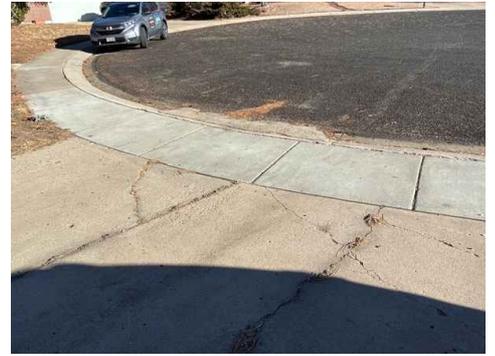
5.2.4 Walkways & Driveways  
**SIGNS OF REPAIR**

It appears that some of the sidewalk and or driveway has been replaced.

Recommendation  
Contact a qualified professional.

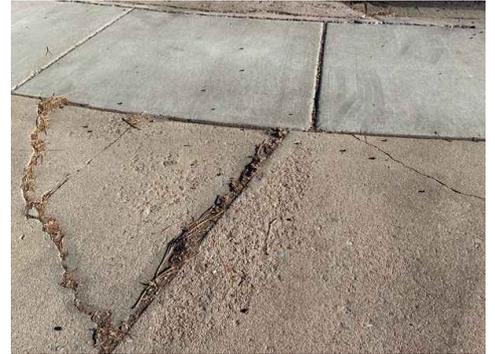
5.2.5 Walkways & Driveways  
**PITTED**

The driveway was pitted in areas. A qualified contractor should evaluate and repair or replace as necessary.

Recommendation  
Contact a qualified concrete contractor.

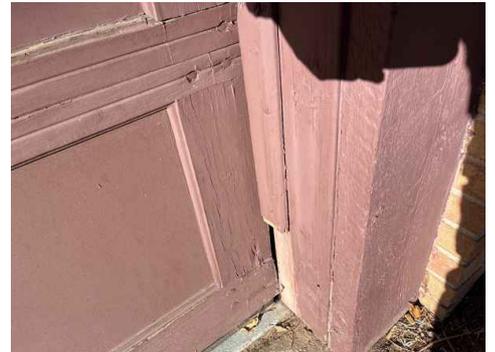
5.3.1 Garage Door Exterior  
**DAMAGED - WEATHER STRIPPING**

The exterior of the garage door has damaged weather stripping. A qualified contractor should inspect and repair as necessary and according to current standards.

Recommendation  
Contact a qualified professional.

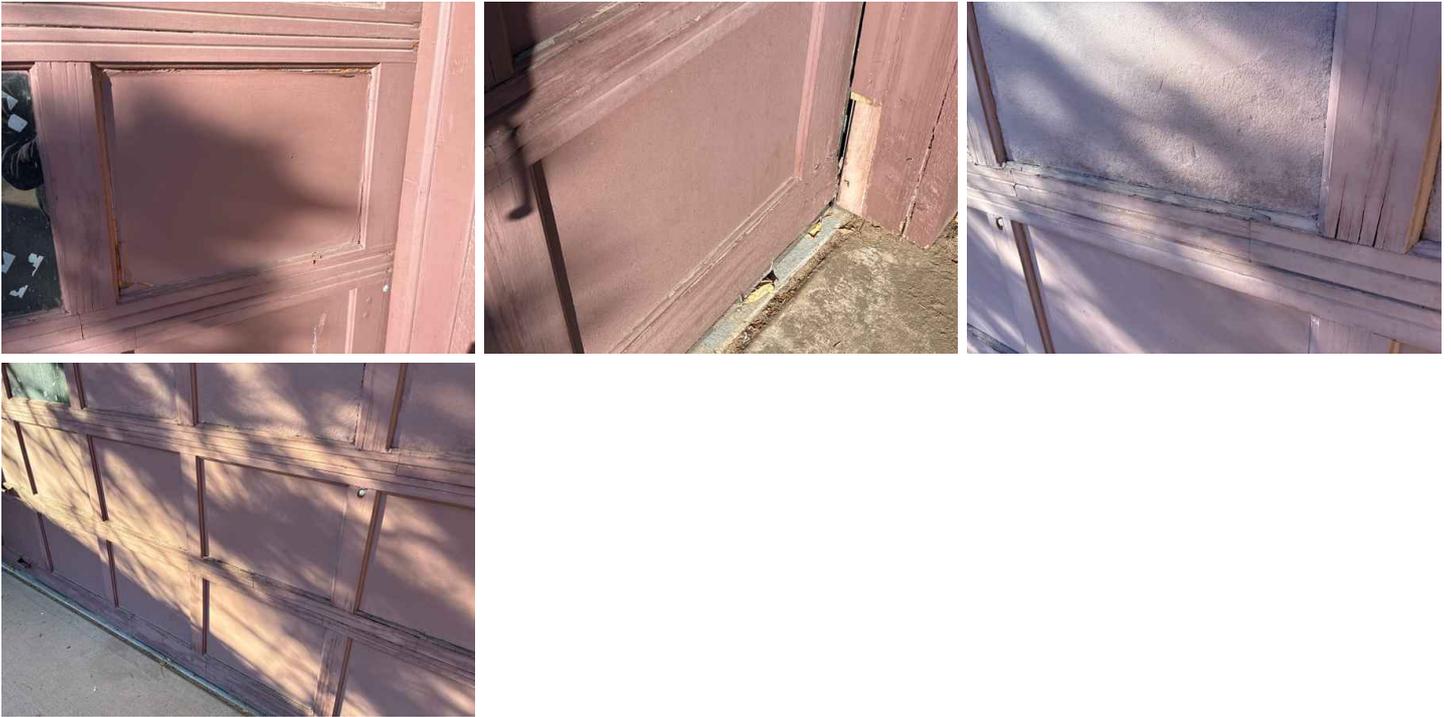
5.3.2 Garage Door Exterior  
**DAMAGED - PANEL(S)**

The exterior of garage door has one or more damaged panels. A qualified contractor should inspect and repair as necessary and according to current standards.

Recommendation  
Contact a qualified professional.

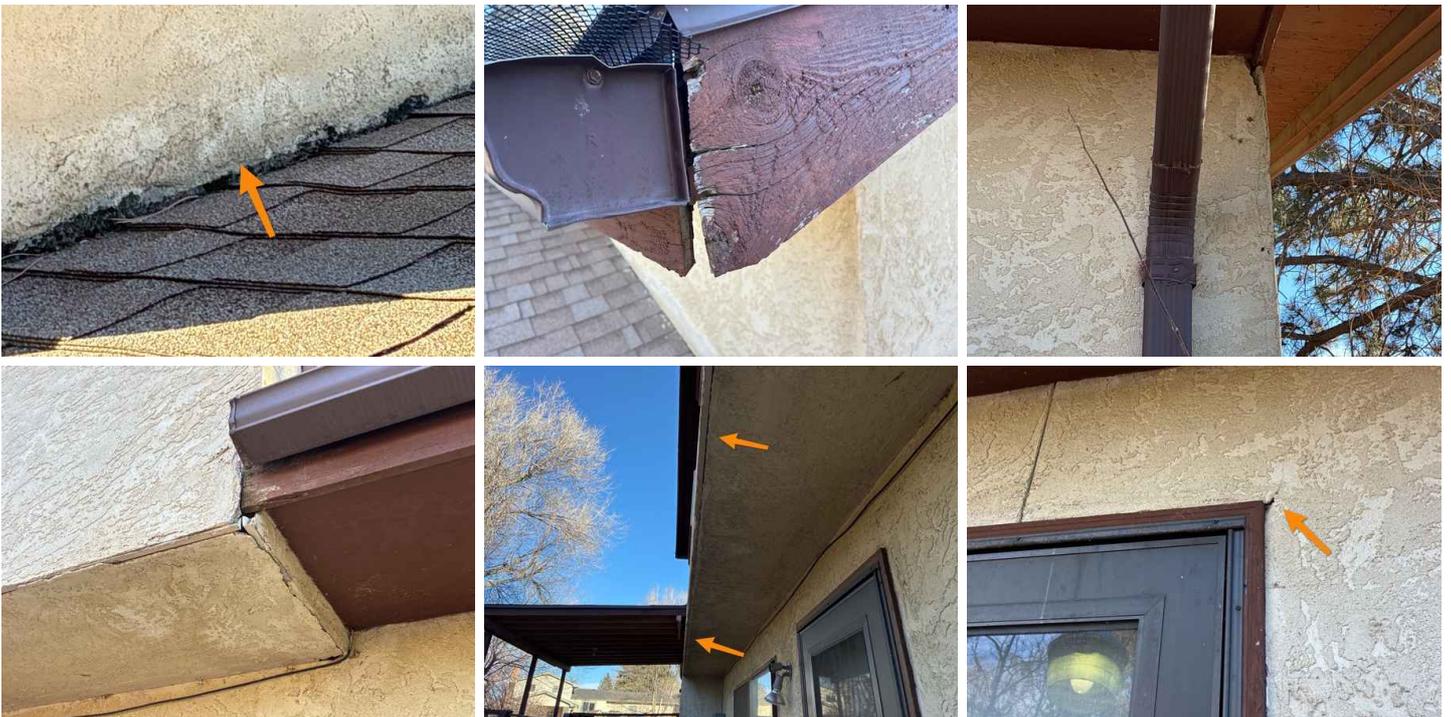
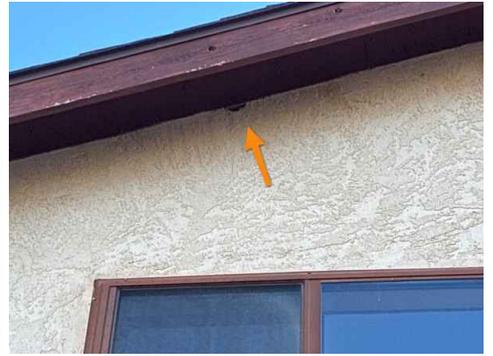
5.4.1 Wall-Covering, Flashing & Trim  
**DAMAGED - SIDING**

The stucco was and/or trim was damaged in areas of the exterior. Multiple areas of the stucco were cracked or damaged, which can allow moisture intrusion into the wall system. A qualified contractor should evaluate and repair or replace as necessary and according to current standards.

Recommendation  
Contact a qualified professional.

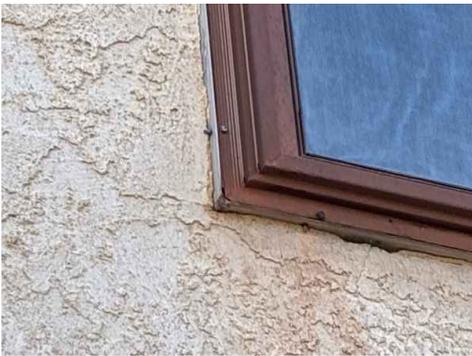
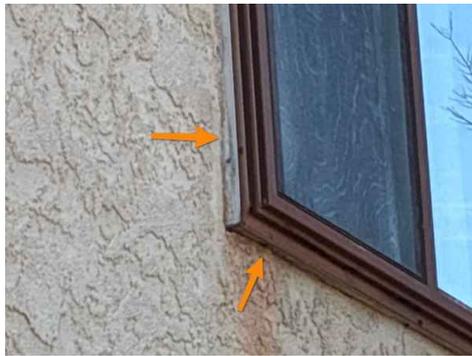
5.4.2 Wall-Covering, Flashing & Trim  
**SEAL GAPS AT INTERSECTIONS**

Gaps at intersections of the siding, trim, and door and window openings, as well as any other holes in the siding, should be sealed with an appropriate sealant to prevent water penetration into the wall system. A qualified contractor should evaluate and repair or replace as necessary.

Recommendation  
Contact a qualified professional.

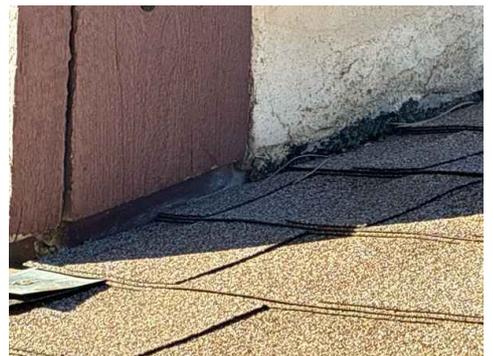
5.4.3 Wall-Covering, Flashing & Trim  
**INADEQUATE ROOF CLEARANCE**

The siding was in direct contact with the roof covering materials in some areas at the time of inspection. This condition can cause deterioration of the bottom edge of the siding at these locations. Ideally, there should be a minimum clearance of at least 1 1/2 inches from the bottom of the siding material to the top of the roof covering material. Recommend further evaluation by a qualified contractor to repair or replace.

Recommendation  
Contact a qualified professional.

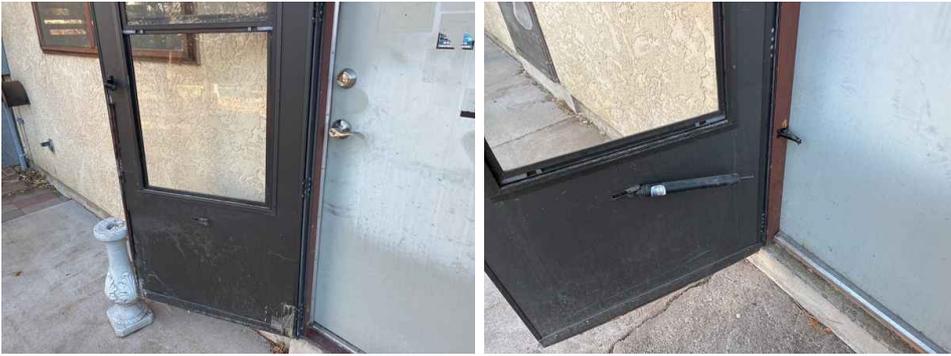
5.6.1 Exterior Doors  
**DAMAGE - DOOR**

The surface of the exterior door was damaged or in poor condition.

A qualified contractor should evaluate and repair or replace as necessary and according to current standards.

Recommendation  
Contact a qualified professional.

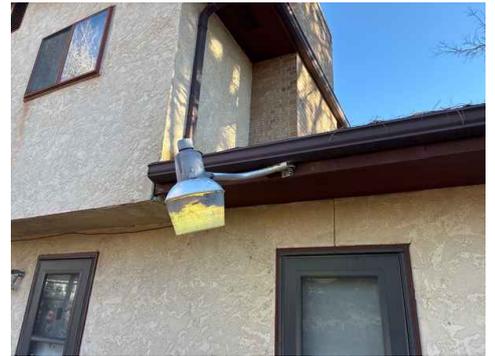
5.7.1 Electrical Fixtures

**LOOSE - FIXTURE**

One or more exterior fixtures were loose and not mounted securely. Recommend a qualified contractor evaluate and repair or replace as needed.

Recommendation  
Contact a qualified professional.

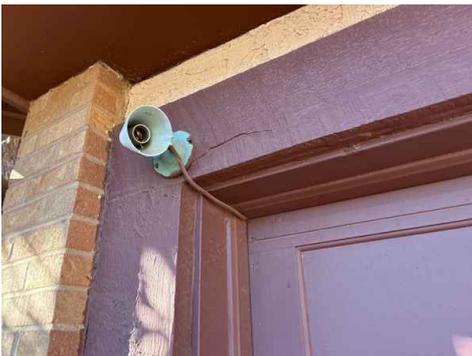
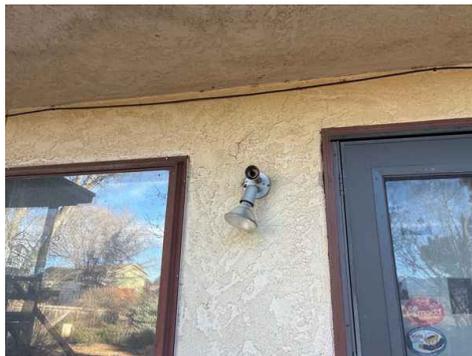
**MISSING OR BROKEN BULB**

Some of the exterior light fixtures had missing or burnt-out bulb(s). The bulb(s) should be replaced, and if still inoperable, a qualified contractor should evaluate and make necessary changes.

Recommendation  
Contact a qualified professional.

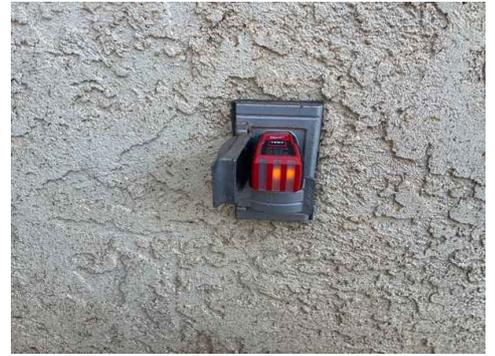
5.8.1 Electrical Outlets

**NO EXTERIOR GFCI**

Although GFCI protection of exterior circuits may not have been required at the time in which this property was built, it is recommended to update the existing exterior electrical circuits to include GFCI protection. A qualified electrical contractor should evaluate and implement according to current standards.

Recommendation  
Contact a qualified professional.

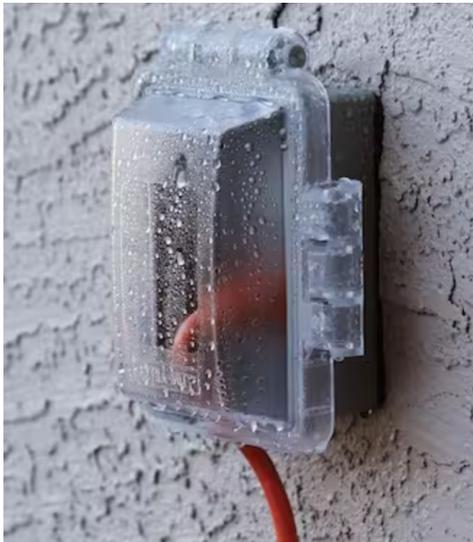
5.8.2 Electrical Outlets

**OUTDATED WEATHERPROOF COVER**

One or more exterior outlets had an older/outdated weatherproof cover, but not an "in use" cover, which is current standard. A qualified contractor should evaluate and replace.

Recommendation  
Contact a qualified professional.

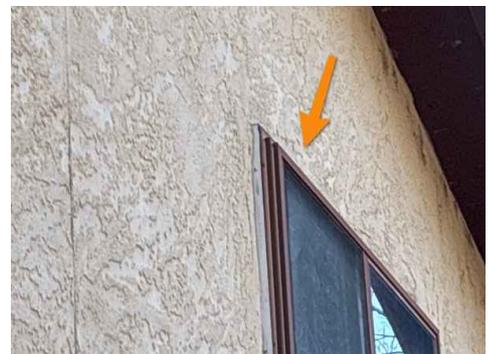
5.9.1 Windows

**MISSING TOP FLASHING**

The top window flashing was missing around the subject property.

Recommendation  
Contact a qualified professional.

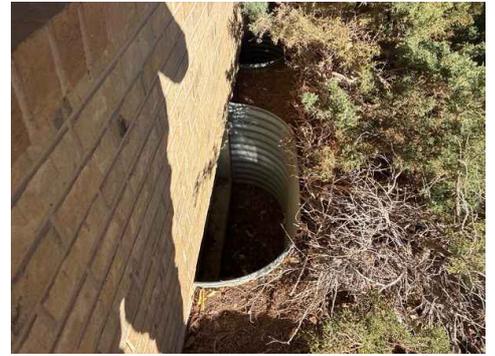
5.10.1 Window Wells

**WINDOW WELLS MISSING COVERS**

Window Well(s) lacked covers and may represent a danger to small children and may trap pests. A qualified contractor should evaluate and repair or replace as necessary.

Recommendation  
Contact a qualified professional.

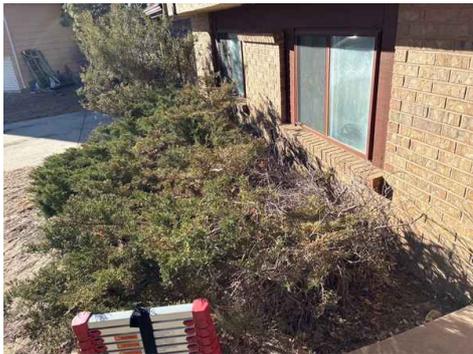
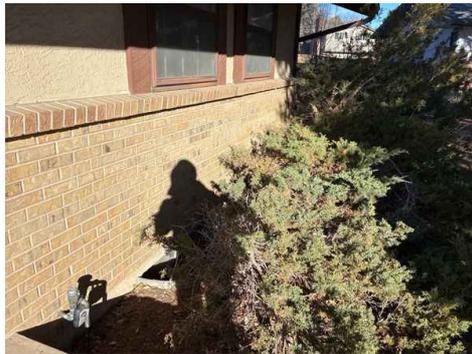
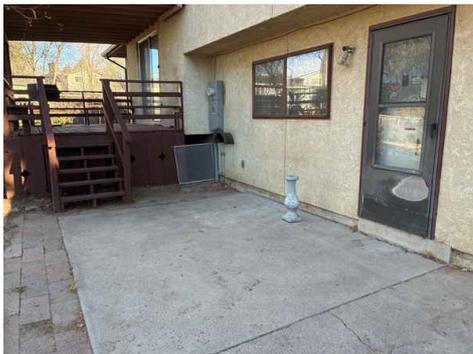
The property had areas of neutral or negative drainage, which will route runoff from precipitation to the foundation. Excessive moisture content in soil supporting the foundation can cause foundation and other structural damage from undermining, heaving or settling, depending on soil composition, moisture content and other conditions. The ground around the property should slope away from all sides. Ideally, 6" of fall in the first 5' is recommended by most soils engineers for landscape areas, and then 2% (1/4" per foot thereafter). Downspouts, surface gutters and drains should also be directing water away from the foundation. A qualified contractor should evaluate and repair as necessary according to current standards.

Recommendation  
Contact a qualified landscaping contractor

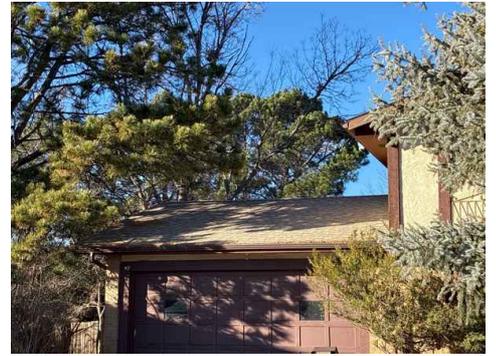
5.11.2 Vegetation, Grading & Drainage  
**TREE BRANCHES OVER PROPERTY**

Large trees near the house have branches which overhang the property. Falling branches due to conditions such as wood decay, high winds or heavy snow loads may cause injury, death or damage. Significant weakening of large branches by conditions such as core decay may not be visible by persons without special training. Consider having these trees evaluated by a qualified arborist. Evaluating trees lies beyond the scope of the general property inspection.

Recommend a qualified contractor evaluate and repair or replace as necessary.

Contact a qualified tree service company.

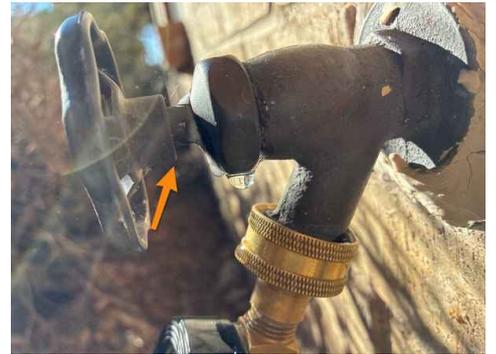
#### 5.13.1 Exterior Faucets (Hose Bibs)

### DRIPS AT KNOB

The outside water faucet drips at the knob when turned on. A qualified contractor should evaluate and repair or replace as necessary and according to current standards.

Contact a qualified professional.

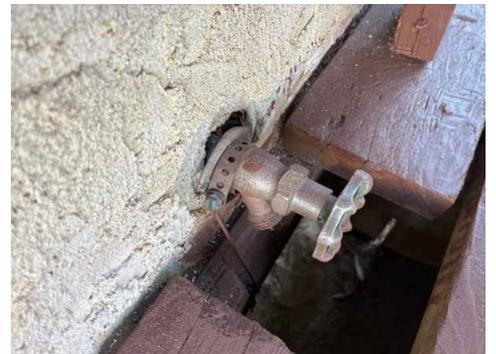
#### 5.13.2 Exterior Faucets (Hose Bibs)

### LOOSE IN WALL

One or more exterior faucet was loose in the wall. The faucet should be securely fastened to the wall using appropriate screws depending on material at location of the faucet. Recommend a qualified contractor evaluate and repair or replace as needed.

Contact a qualified professional.

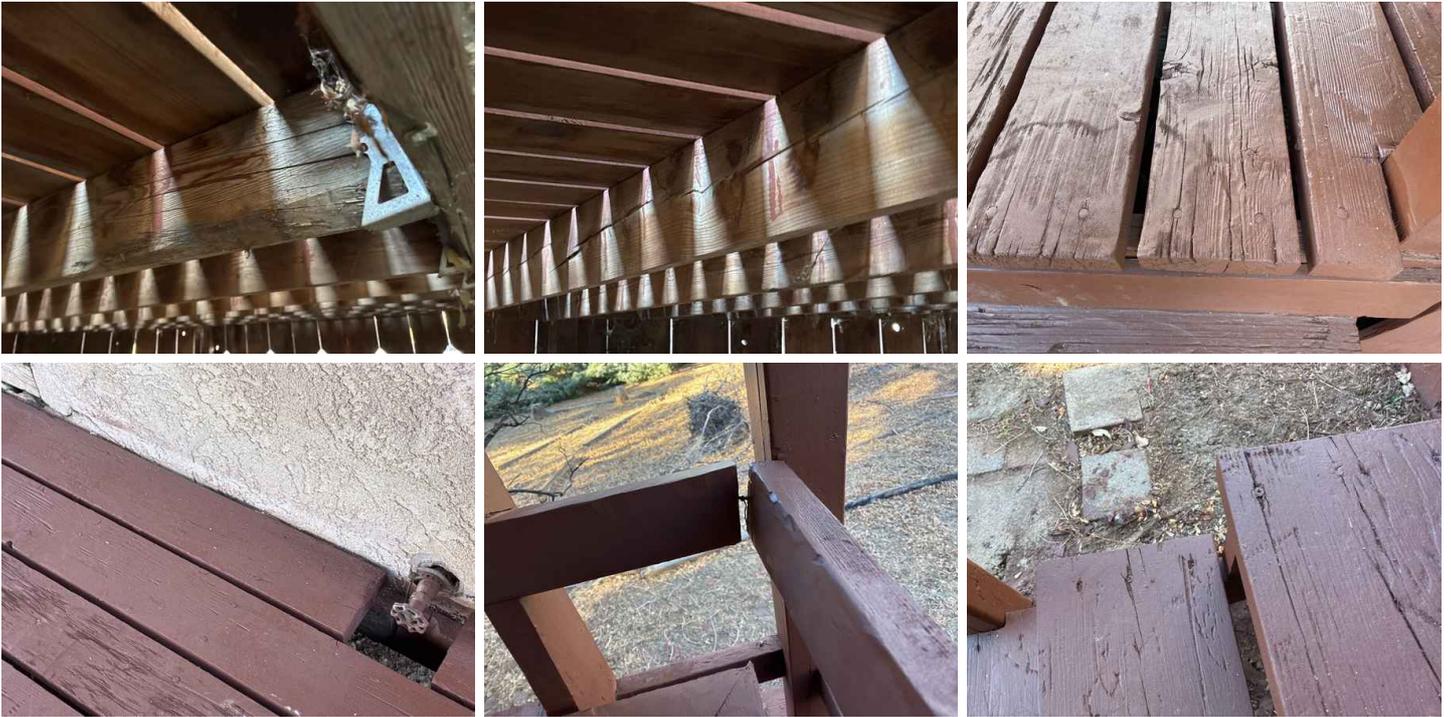
#### 5.18.1 Decks & Balconies

### DETERIORATED - STRUCTURE

There were deteriorated structural components visible at the deck. Cracks in the floor joists, popped nails, damaged/splintered floors were present. Depending on the severity of the deterioration, use of the deck should be cautiously monitored. A qualified contractor should evaluate and repair or replace as necessary.

Contact a qualified deck contractor.

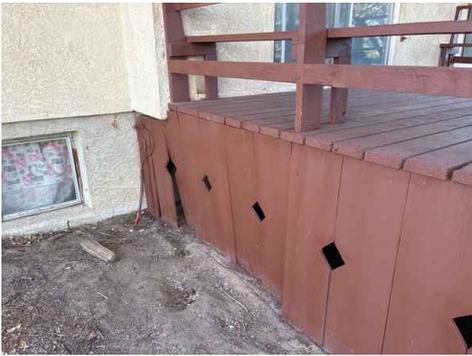
No Flashing

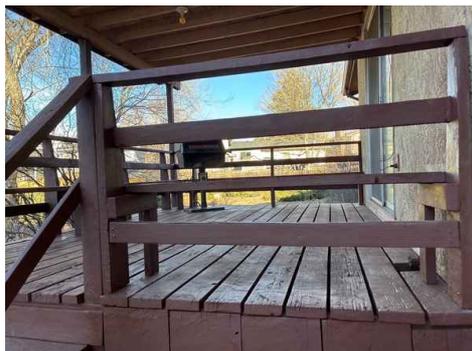
5.19.1 Railings & Handrails  
**SPINDLE SPACING OVER 4"**

4-inch sphere opening at a guard

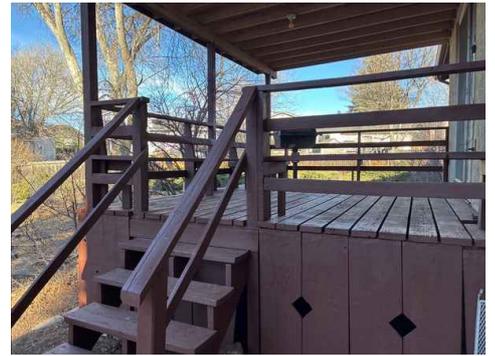
5.19.2 Railings & Handrails  
**HORIZONTAL RAILINGS**

The guard/hand rail had horizontal railings. This creates a climbing risk and a fall or injury could occur if not corrected. A fall or injury could occur if not corrected. A qualified contractor should evaluate and repair or replace as necessary.

Recommendation  
Contact a qualified professional.

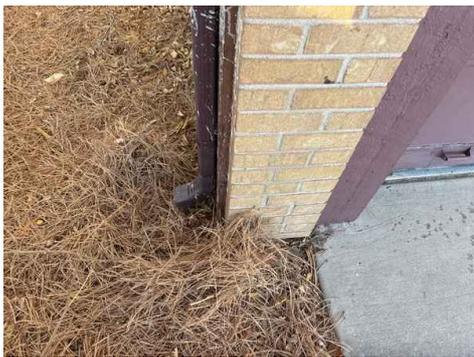
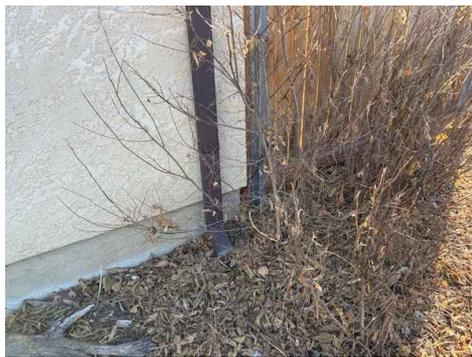
5.20.1 Roof Drainage - Downspouts & Extensions  
**MISSING - EXTENSIONS**

Downspout(s) are missing extensions. This condition may cause problems by introducing excessive amounts of moisture to the soil beneath the foundation. A qualified contractor should evaluate and repair or replace as necessary and according to current standards.

Recommendation  
Contact a qualified professional.

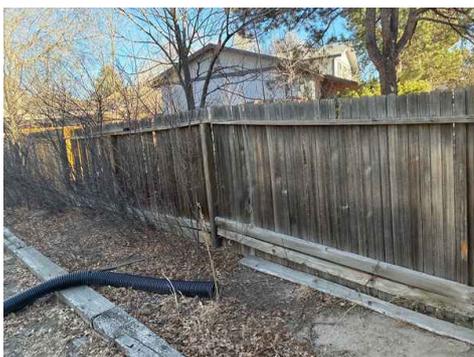
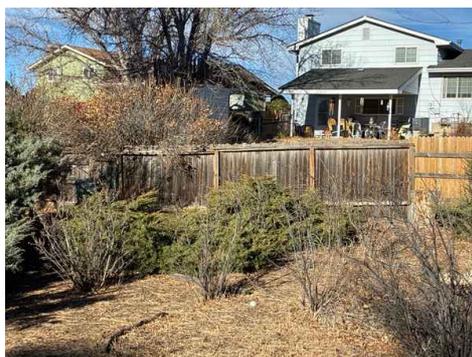
5.21.1 Additional Structures  
**FENCE - REPAIRS NEEDED**

The fence was leaning or damaged in areas. Recommend a qualified contractor evaluate and repair or replace as needed.

Recommendation  
Contact a qualified professional.

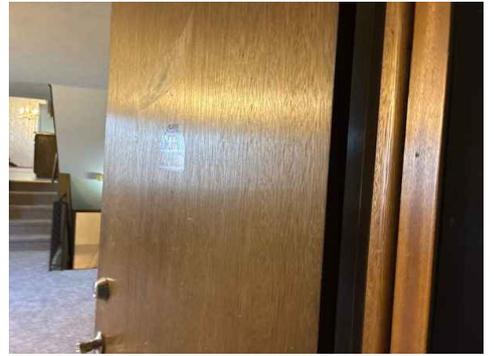
The door between the garage and the living space did not appear to be a fire-rated door and did not have a label. This is a fire hazard. The door between the garage and the house should be a solid wood door at least 1-3/8 inches thick, a solid or honeycomb-core steel door at least 1-3/8 inches thick, or a 20-minute fire-rated door. This means that should a fire occur in garage, the occupant door does not provide protection until firemen arrive. A qualified contractor should evaluate and repair or replace as necessary.

## Recommendation

Contact a qualified professional.

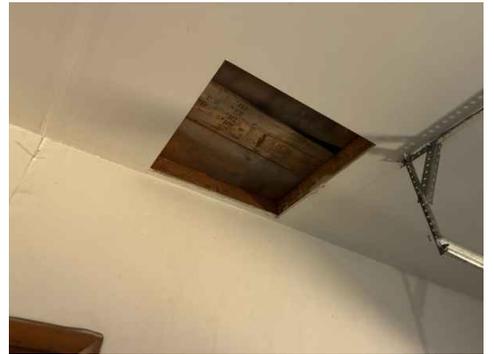
## 6.3.1 Ceiling, Walls &amp; Firewalls

**FIREWALL BREAK - ATTIC ACCESS**

Recommend a qualified contractor evaluate and repair or replace as needed.

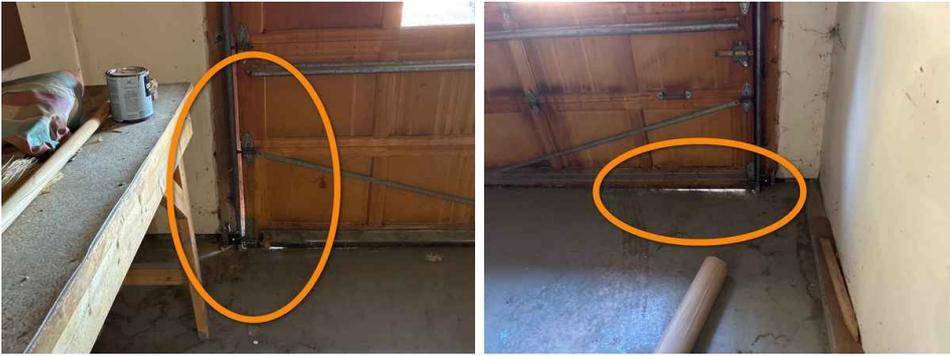
**DAMAGE - WEATHER STRIPPING**

The weather stripping at the bottom edge of the overhead garage door is damaged or insufficient. A qualified contractor should evaluate and repair or replace as needed.

Contact a qualified garage door contractor.

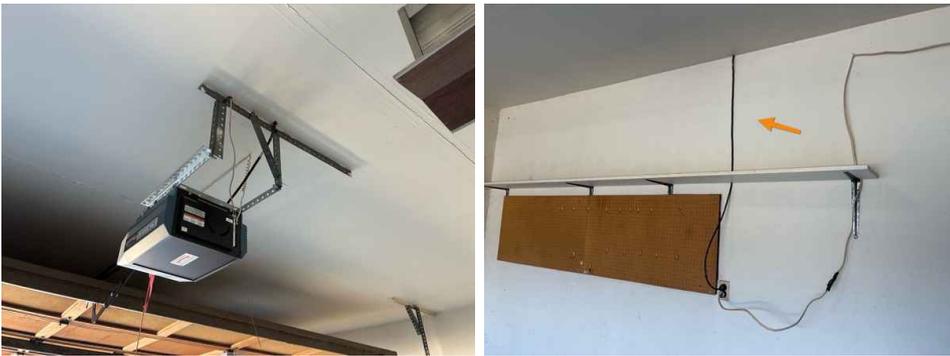
6.6.1 Door Opener  
**EXTENSION CORD USED**

An extension cord was being used to power the garage door operator. Extension cords are for temporary use only and the operator should be plugged in to a dedicated outlet. A qualified electrical contractor should evaluate and repair or replace as necessary.

Recommendation  
 Contact a qualified electrical contractor.

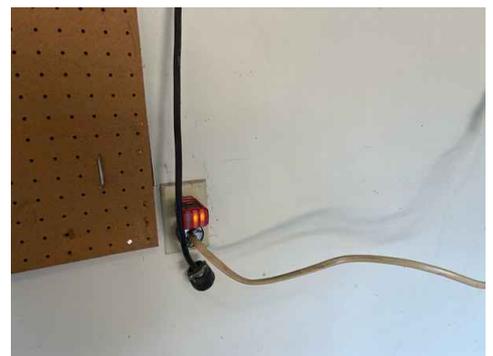
6.7.1 Electrical Outlets & Fixtures  
**NO GFCI PROTECTION**

Recommend installing GFCI outlets as necessary.

Recommendation  
 Contact a qualified electrical contractor.

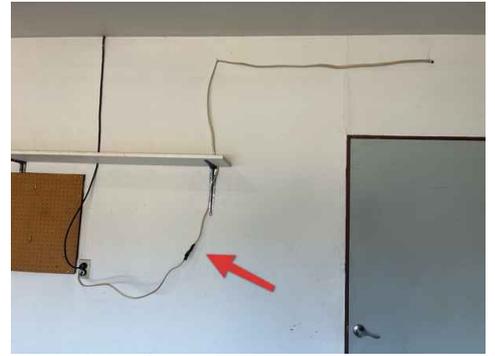
6.7.2 Electrical Outlets & Fixtures  
**DEFECT - WIRING**

Several defects were noted in the electrical wiring in the garage. The wiring, light fixtures, outlets, and/or light switches were not installed according to current standards.

Recommend a qualified electrical contractor to evaluate all electrical components in the garage and repair or replace as needed.

Contact a qualified electrical contractor.

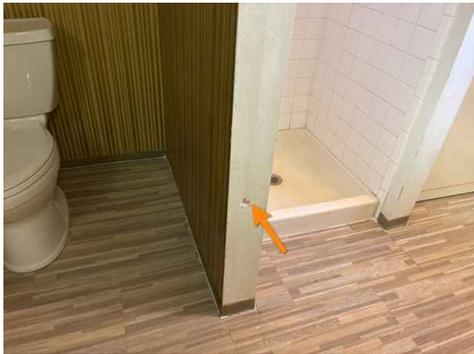
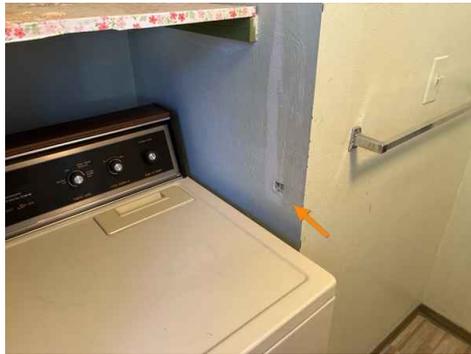
7.2.1 Ceilings & Walls  
**DAMAGED - WALLS**

The walls showed signs of minor damage and wear. A qualified contractor should evaluate and repair or replace as necessary.

Recommendation

Contact a qualified professional.

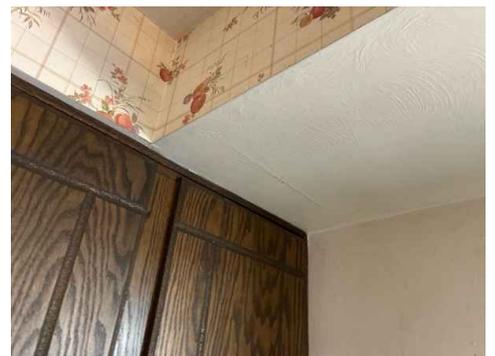
7.2.2 Ceilings & Walls  
**SIGNS OF REPAIR-CEILINGS**

The ceilings had signs of previous repair. A qualified contractor should evaluate and repair or replace as necessary.

Recommendation

Contact a qualified professional.

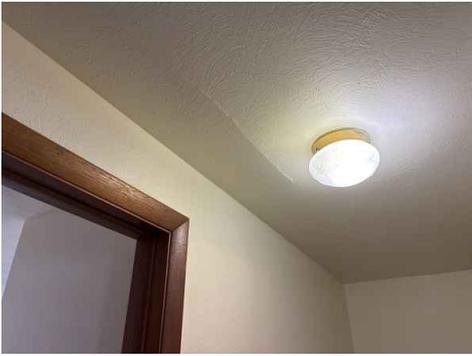
7.2.3 Ceilings & Walls  
**DAMAGED - CEILINGS**

The ceiling had a repair, likely from someone stepping on the drywall in the attic. A qualified contractor should evaluate and repair or replace as necessary.

Recommendation

Contact a qualified professional.

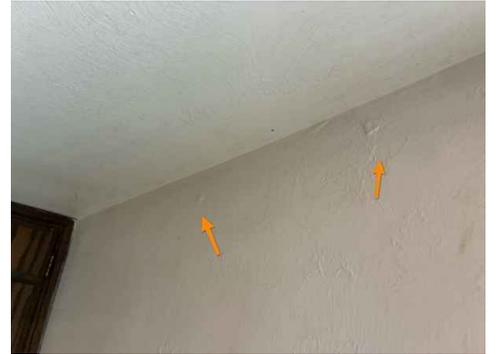
7.2.4 Ceilings & Walls  
**NAIL POPS-WALLS**

There were "nail pops" visible on the interior walls. A qualified contractor should evaluate and repair or replace as necessary.

Recommendation  
Contact a qualified professional.

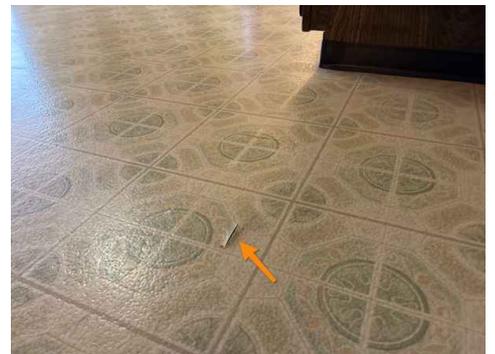
7.3.1 Floors  
**FLOOR DAMAGED**

There appeared to be some damage to the interior flooring in areas of the interior.

Recommendation  
Contact a qualified professional.

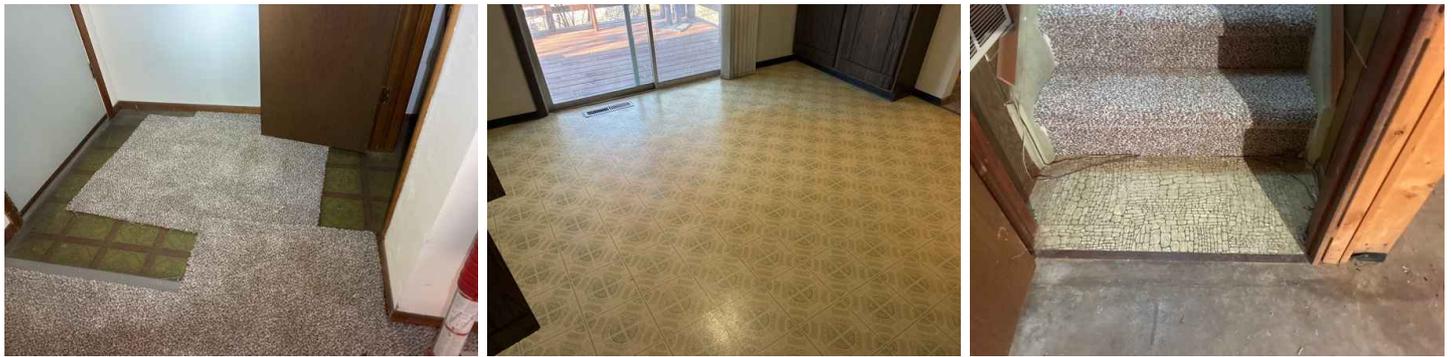
The property had tiles that may contain asbestos. A qualified contractor should evaluate and repair or replace as necessary. Flooring, including sheet vinyl, vinyl or asphalt floor tiles and any associated paper-like backing, mastic, adhesive or glue, may contain asbestos. In the past, asbestos fibers were added during the production of flooring materials to strengthen the flooring and to increase its durability. Flooring that contains asbestos, when intact and in good condition, is generally considered non-friable and is not hazardous. Heat, water, weathering or aging can weaken flooring to the point where it is considered friable. Friable material includes any material containing more than 1 percent asbestos that can be crumbled, pulverized or reduced to powder with hand pressure. This includes previously non-friable material which has been damaged to the extent that it may be crumbled, pulverized or reduced to powder by hand pressure and can also be made friable during its removal. Friable materials can release asbestos fibers into the air. Once in the air, asbestos fibers present a health hazard to people who inhale those fibers.

Recommendation  
Contact a qualified professional.

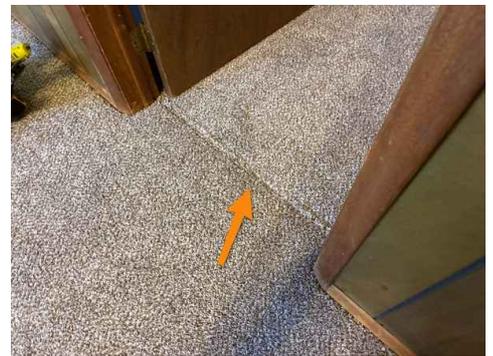
**CARPET REVEALED A SEAM**

The carpet revealed a seam. A qualified contractor should evaluate and repair or replace as necessary.

Recommendation  
Contact a qualified professional.

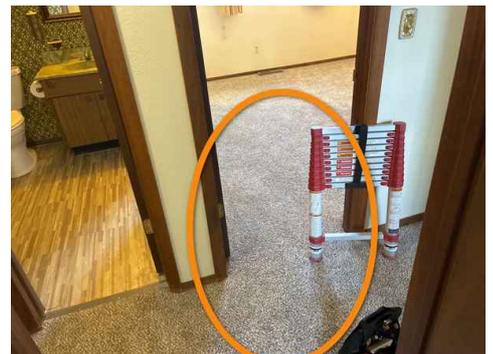
The floor squeaks. A qualified contractor should evaluate and repair or replace as necessary.

Recommendation  
Contact a qualified professional.

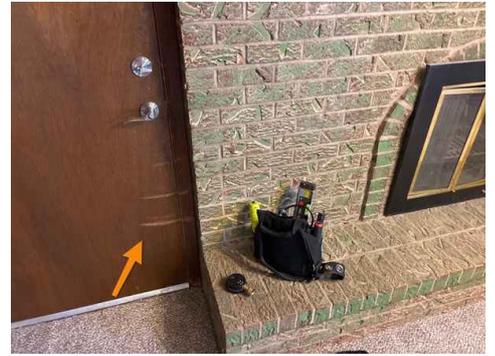
**DAMAGED - DOOR**

The door was damaged. A qualified contractor should evaluate and repair or replace as necessary.

Recommendation  
Contact a qualified professional.

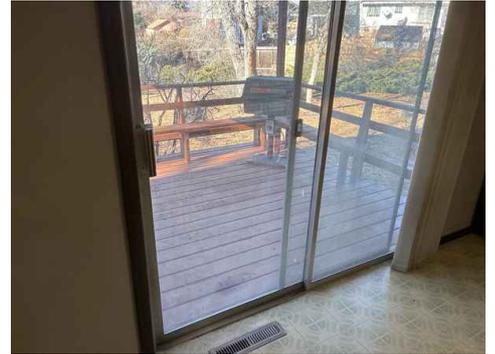
**NOT OPERATE SMOOTHLY**

The door did not operate smoothly. A qualified contractor should evaluate and repair or replace as necessary.

Recommendation  
Contact a qualified professional.
