## SUMMARY

Ron Long  
Master Inspector  
Integrated Home and Environmental  
Inspections  
720-916-6829  
[ron@integratedinspections.org](mailto:ron@integratedinspections.org)

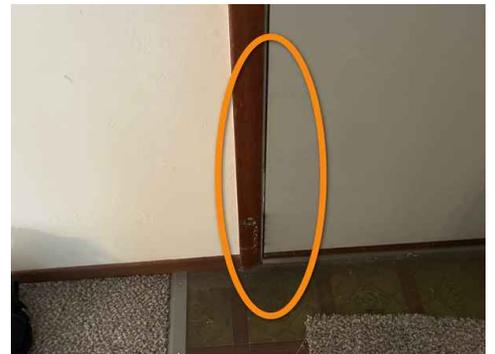
**WEATHERSTRIPPING DAYLIGHT**

The door revealed daylight in areas when latched which may indicate missing or damaged weatherstripping. A qualified contractor should evaluate and repair or replace as necessary.

Recommendation  
Contact a qualified professional.

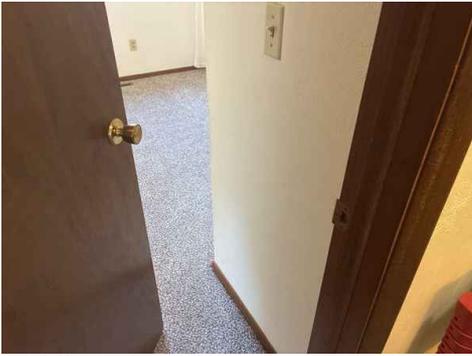
The door would not latch when closed, and may need adjustment at the strike plate and/or door frame to latch properly. A qualified contractor should evaluate and repair or replace as necessary.

Recommendation  
Contact a qualified professional.

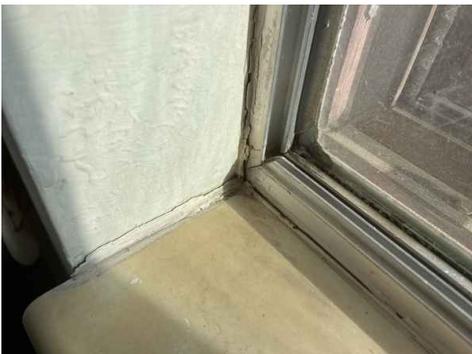
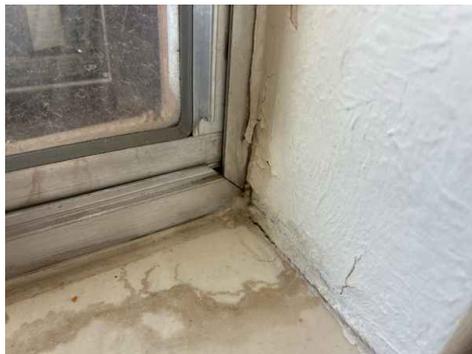
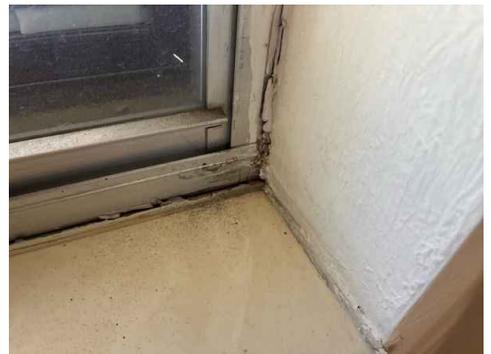
**CAULKING - DETERIORATED**

The interior caulking or grout around the perimeter of the windows was cracked or deteriorating and needed new caulking. This is common and due to thermal expansion and contraction of the window frame. Recommend a qualified contractor to evaluate and seal all windows as necessary.

Recommendation  
Contact a qualified professional.

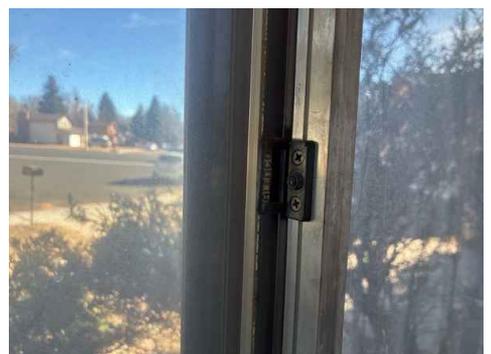
Missing- Lower Bedroom

**LOCK DAMAGED/MISSING**

The window had damaged or missing lock hardware. A qualified contractor should evaluate and repair or replace as necessary.

Recommendation  
Contact a qualified professional.

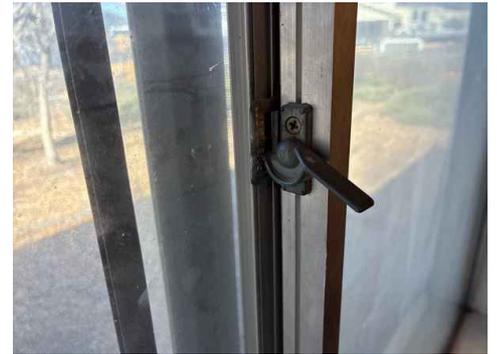
The window did not lock properly. A qualified contractor should evaluate and repair or replace as necessary.

Recommendation  
Contact a qualified professional.

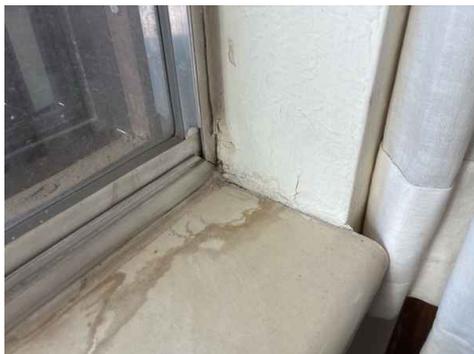
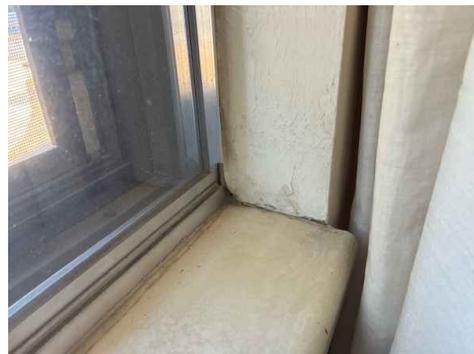
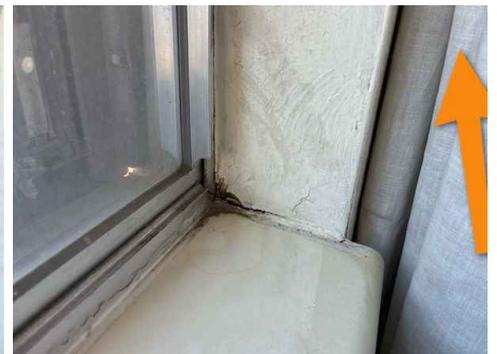
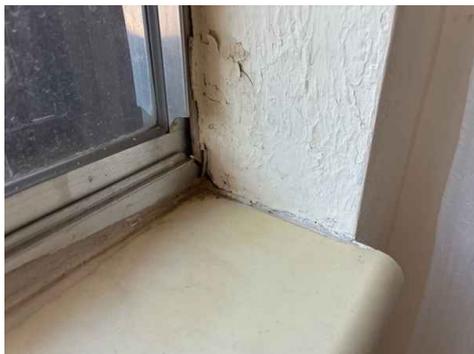
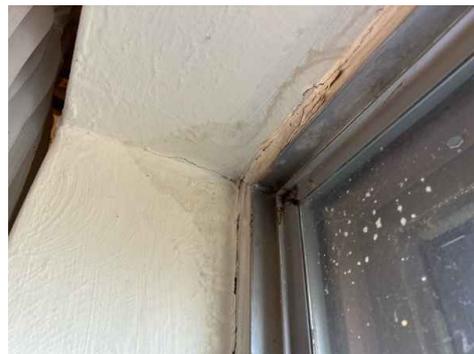
One window had signs of water penetration. A qualified contractor should evaluate and repair or replace as necessary.

Recommendation  
Contact a qualified professional.

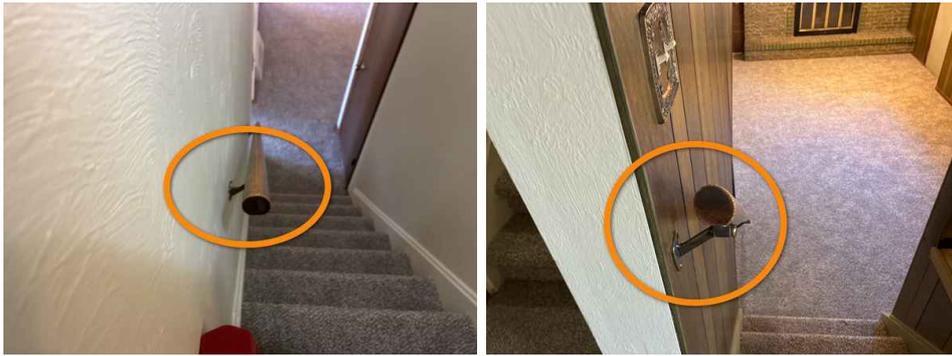
An interior handrail was not continuous throughout an interior stairway. Handrails for stairs must be continuous for the full length of the stairway.

Recommendation  
Contact a qualified professional.

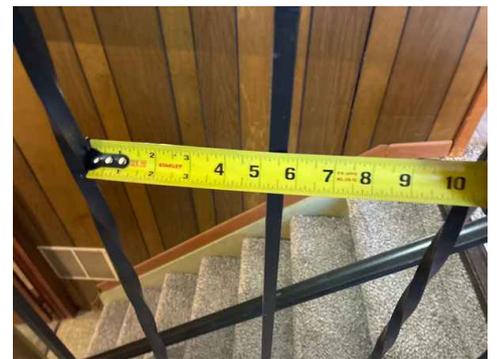
7.8.2 Stairways & Railings  
**SPINDLE SPACING OVER 4"**

At the interior stairs, the handrail/guardrail had spacing between components that were too far apart. Spacing of more than 4 " could allow a child or pet to fall through. A fall or injury could occur if not corrected. A qualified contractor should evaluate and repair or replace as necessary.

Recommendation  
Contact a qualified professional.

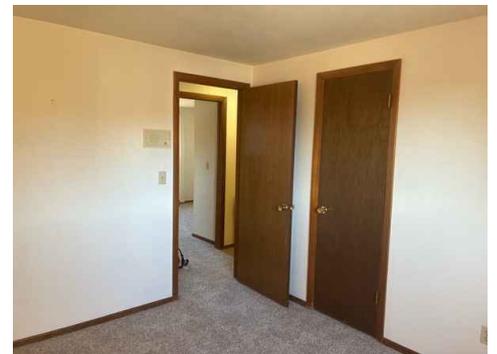
7.9.1 Smoke & CO Detectors  
**SMOKE DETECTOR MISSING**

The smoke detector was missing in bedrooms. A qualified person should replace as needed. The existing smoke detectors were tested if present, but they are only noted as to presence and operation as of date of inspection. Smoke detectors may work today but not work when you need them to work. This is why it is important for you to test them on a regular basis, monthly at least. Smoke detectors are recommended by the U.S. Product Safety Commission to be installed inside each bedroom and adjoining hallway and on each living level of the property and basement level.

Recommendation  
Contact a qualified professional.

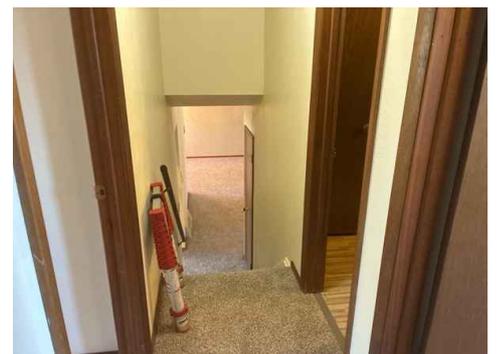
7.9.2 Smoke & CO Detectors  
**CO DETECTOR MISSING**

Carbon monoxide detectors were not installed within a specified distance, 15', of each room lawfully used for sleeping purposes. The inspector recommends installation of carbon monoxide detectors in appropriate locations. Colorado House bill 1091 became effective on July 1, 2009 that requires Carbon Monoxide detectors to be installed in most properties that has a fuel-burning heater or appliance, a fireplace, or an attached garage.

Recommendation  
Contact a qualified professional.

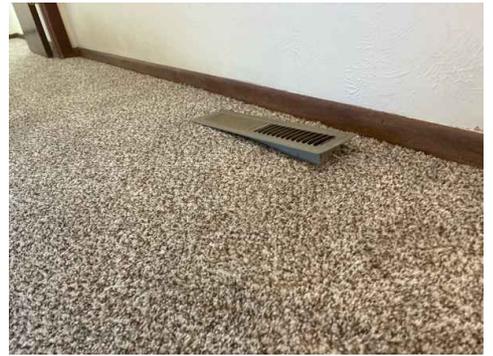
### 7.10.1 Installed Heat Source **SUPPLY REGISTER COVER MISSING/DAMAGED**

The supply register cover was missing or damaged. A qualified contractor should evaluate and repair or replace as necessary.

Recommendation  
Contact a qualified professional.

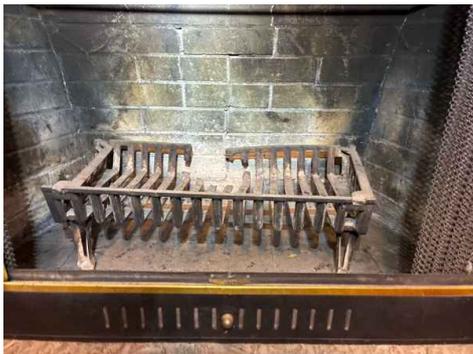
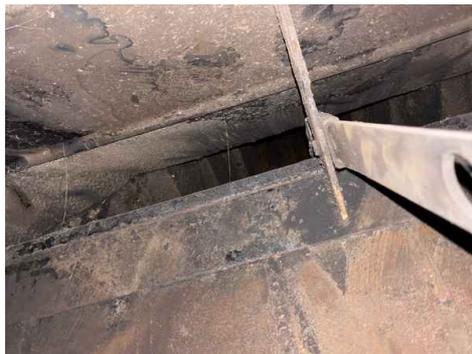
### 7.11.1 Wood Burning Fireplace **CLEANING NEEDED**

The visible areas of the firebox and chimney flue were dirty at the time of the inspection. Most of the chimney flue was inaccessible and was not inspected. Dirty flues are potential fire hazards and should be cleaned by a professional. Recommend having the chimney evaluated by a C.S.I. (Chimney Safety Institute) -qualified chimney sweep.

Recommendation  
Contact a qualified professional.

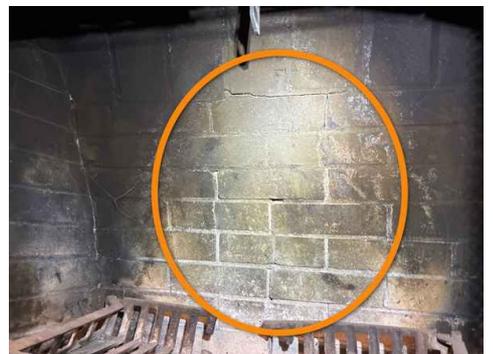
### 7.11.2 Wood Burning Fireplace **DAMAGE TO FIREPLACE INTERIOR**

The fireplace had damage to the interior chamber. A qualified contractor should evaluate and repair or replace as necessary.

Recommendation  
Contact a qualified professional.

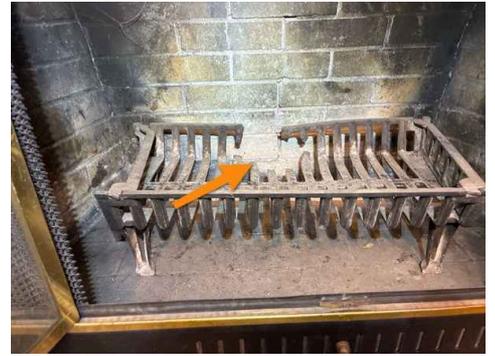
### 7.11.3 Wood Burning Fireplace **RACK DAMAGED**

The firewood rack was damaged. A qualified contractor should repair or replace.

Recommendation  
Contact a qualified professional.

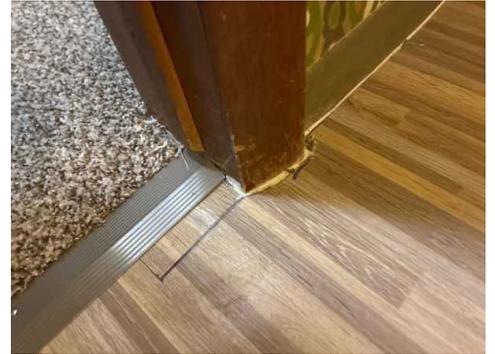
### FLOOR DAMAGED

There appeared to be some damage to the interior flooring in areas of the interior.

Recommendation  
Contact a qualified professional.

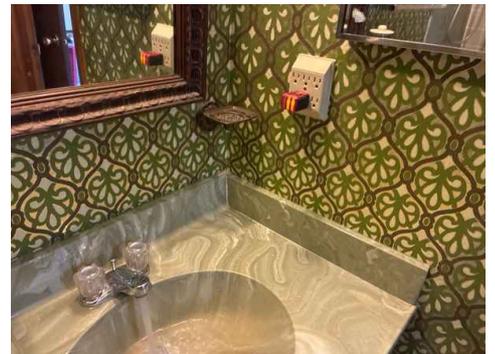
### NO GFCI PROTECTION

No ground fault circuit interrupter (GFCI) protection was provided for the bathroom electrical outlets. Although GFCI protection of bathroom circuits may not have been required at the time of in which this property was built, as general knowledge of safe building practices has improved, building standards have changed to reflect current understanding. The inspector recommends updating the existing bathroom electrical circuits to provide GFCI protection. This can be achieved by:

A qualified contractor should evaluate and repair or replace as necessary.

Recommendation  
Contact a qualified professional.

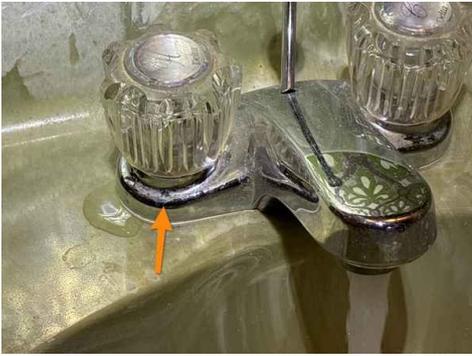
### LEAK - SINK FAUCET

The sink faucet leaked. A qualified contractor should evaluate and repair or replace as necessary.

Recommendation  
Contact a qualified professional.

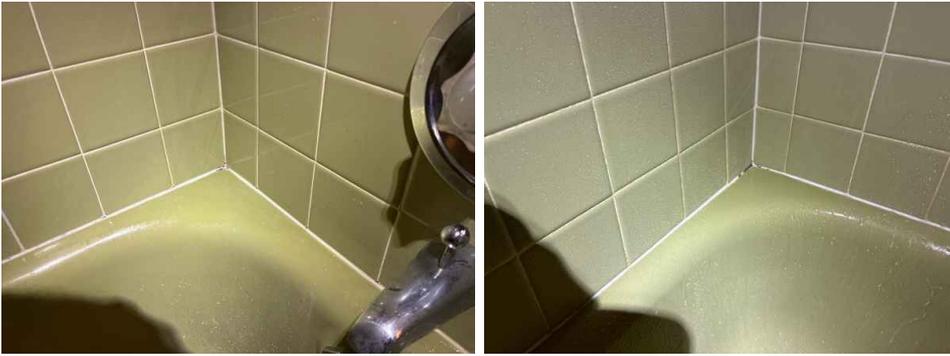
#### **DETERIORATED - CAULKING/GROUT**

Caulking in the shower/tub area was deteriorated at the time of inspection. Recommend a qualified contractor evaluate and repair or replace as necessary.

#### Recommendation

Contact a qualified professional.

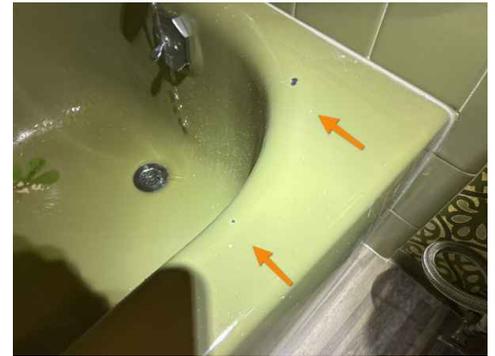
**CHIPPED - TUB**

The bathtub finish was chipped or damaged. A qualified contractor should evaluate and repair or replace as necessary.

Recommendation  
Contact a qualified professional.

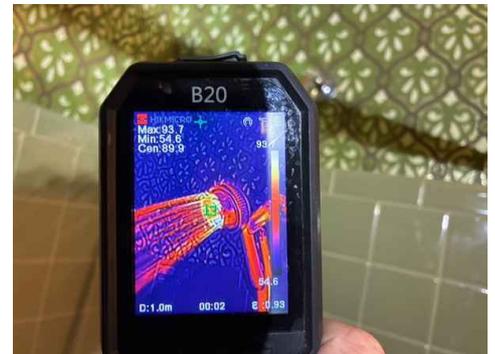
8.14.1 Water Supply Functional Flow

**PRESSURE DROP**

With at least 2 plumbing fixtures running water, there was a noticeable drop in the water flow after the toilet was flushed. A qualified contractor should evaluate and repair or replace as necessary.

Recommendation  
Contact a qualified professional.

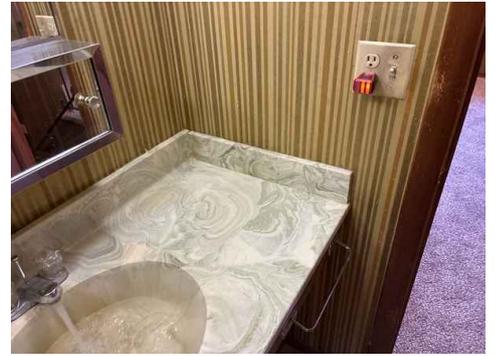
### 9.7.1 Cabinets & Counters

#### CAULKING - BACK SPLASH

The counter top needs caulking with silicone along the back splash. A qualified contractor should evaluate and repair or replace as necessary.

Contact a qualified professional.

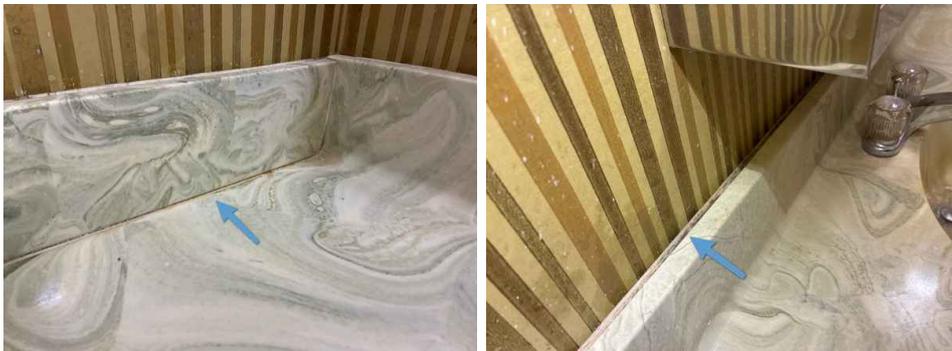
### 9.7.2 Cabinets & Counters

#### CHIPPED - COUNTER

The sink was stained/damaged. A qualified contractor should evaluate and repair or replace as necessary.

Contact a qualified professional.

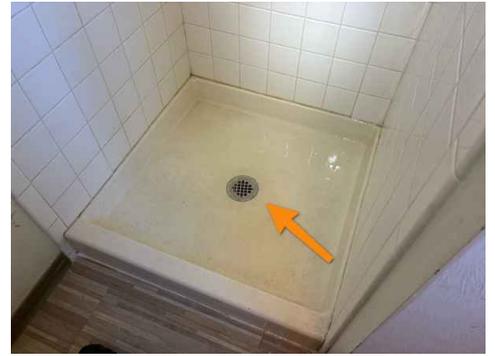
### 9.12.1 Tub, Shower Area **DETERIORATED - CAULKING/GROUT**

Caulking in the shower/tub area was deteriorated at the time of inspection. Recommend a qualified contractor evaluate and repair or replace as necessary.

Recommendation  
Contact a qualified professional.

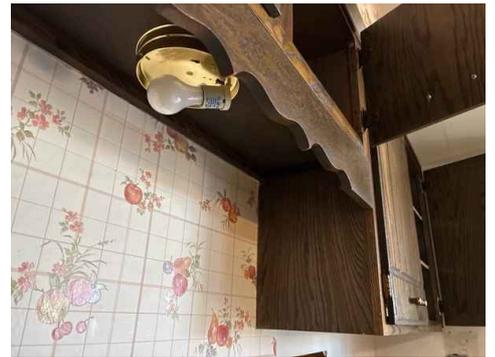
10.4.2 Electrical Fixtures & Switches  
**MISSING - COVER/GLASS**

The light fixture was missing cover/glass. A qualified contractor should evaluate and repair or replace as necessary.

Recommendation  
Contact a qualified professional.

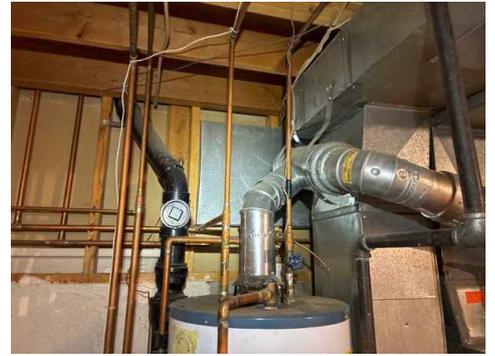
12.12.1 Water Temperature  
**WATER TEMPERATURE LOW**

The water temperature was below the suggested range of 120-130 degrees. Recommend adjusting the water heater thermostat first. If water does not reach the acceptable range then a qualified contractor should evaluate and repair or replace as necessary.

Recommendation  
Contact a qualified professional.

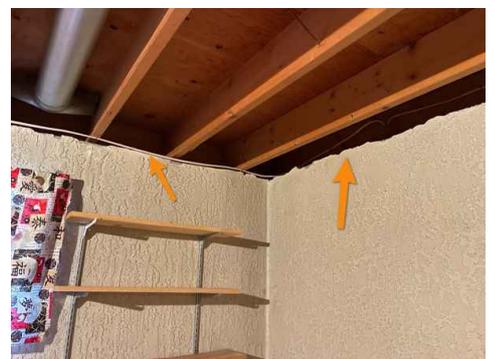
17.7.1 Insulation  
**NO INSULATION**

There is no insulation on the basement exterior walls or floor system. Heat loss can occur more on this property than one that is properly insulated. A qualified contractor should evaluate and install as necessary.

Recommendation  
Contact a qualified professional.

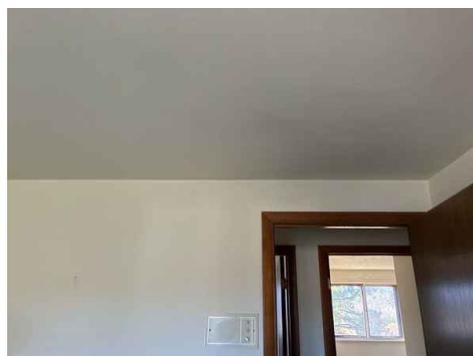
Master Bedroom

An infrared inspection of the building envelope from the interior reveal defects in the insulation and or the presence of moisture intrusion. A qualified contractor should evaluate and repair over place as necessary.

Recommendation  
Contact a qualified professional.
