SUMMARY
11544 Green Ct, Conifer, CO 80433
Ian Graham
February 23, 2023

Ron Long
Master Inspector
Integrated Home and Environmental
Inspections
720-219-0129
ron@integratedinspections.org

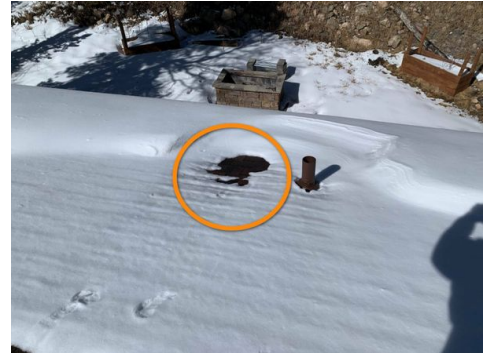
2.1.1 Coverings

UNEVEN MELTING

In the attic below this area, insulation is lacking and should be replaced once the bathroom fan has been addressed. The lack of insulation is also introducing warm air into the attic and has the potential to condensate and create moisture issues. Recommend adding insulation to fill the gap.

Recommendation
Contact a qualified professional.

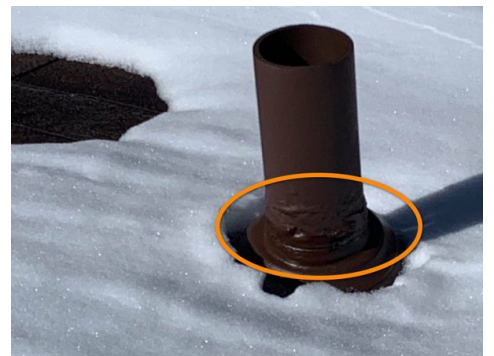
2.4.1 Skylights, Chimneys & Other Roof Penetrations

RUBBER BOOT DAMAGED

One or more vent boot was not installed properly or was damaged; the boot is beginning to deteriorate and should be replaced with the next roof. This condition could allow moisture intrusion into the roof system; recommend a sealant where the boot holds the pipe. A qualified contractor should evaluate and repair or replace.

Recommendation
Contact a qualified professional.

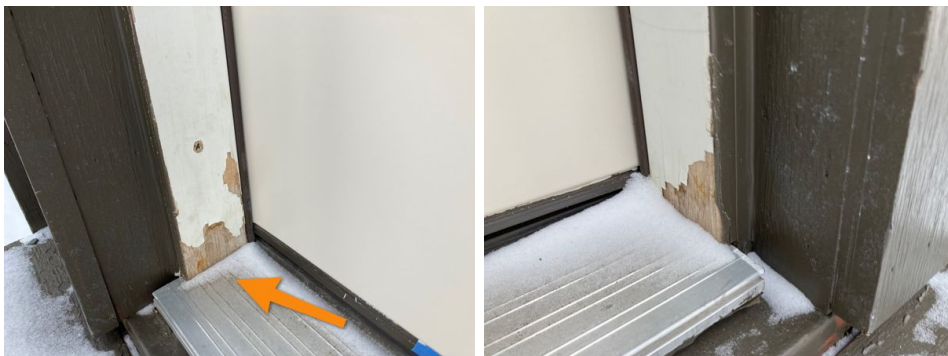
3.2.1 Siding, Flashing & Trim

PAINT NEEDED

Areas of siding or trim were worn and in need of maintenance. Recommend a qualified painter touch up the areas in need.

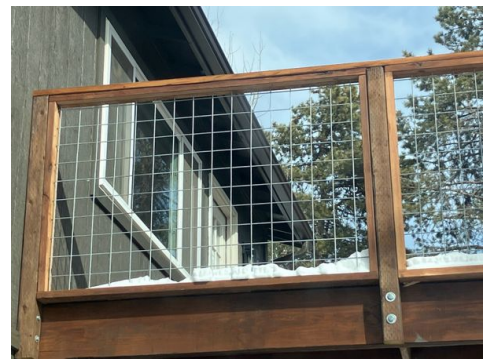
3.4.1 Decks, Balconies, Porches & Steps

HORIZONTAL RAILING

These types of railing are child safety hazards. Recommend either changing the rails to vertical only or not allowing children to play on the deck without supervision.

Recommendation

Contact a qualified professional.

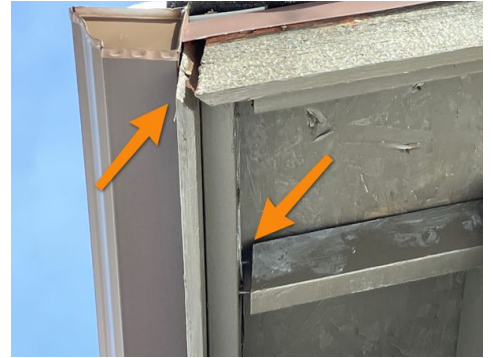
3.5.1 Eaves, Soffits & Fascia

FASCIA - LOOSE

One or more sections of the fascia are loose. Recommend qualified roofer evaluate & repair.

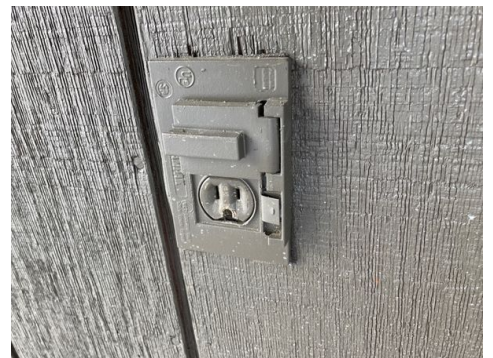
3.6.1 Lighting Fixtures, Switches & Receptacles

COVER PLATES MISSING

One or more receptacles are missing a cover plate. This causes short and shock risk. Recommend installation of plates.

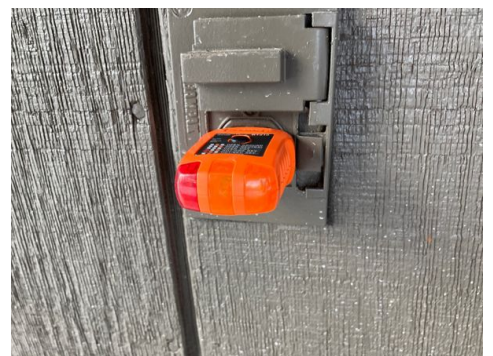
3.6.2 Lighting Fixtures, Switches & Receptacles

NO GFCI PROTECTION

No ground fault circuit interrupter (GFCI) protection was provided for the electrical outlets. Although GFCI protection of the circuits may not have been required at the time in which this property was built, as general knowledge of safe building practices has improved with the passage of time building standards have changed to reflect current understanding. A qualified contractor should update the outlets or breakers.

Recommendation

Contact a qualified professional.

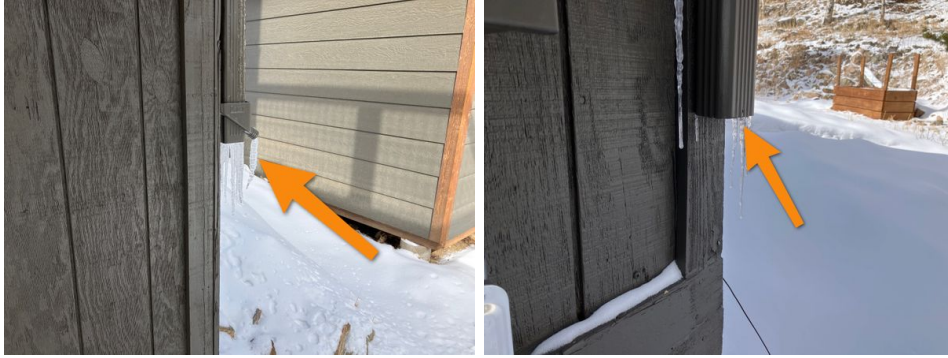
3.11.1 Downspouts

MISSING EXTENSIONS

The downspouts are missing extensions. These are necessary to keep water away from the foundation of the house. A qualified contractor should install extensions to shed water at least 6 feet away from the house.

Recommendation
Contact a qualified professional.

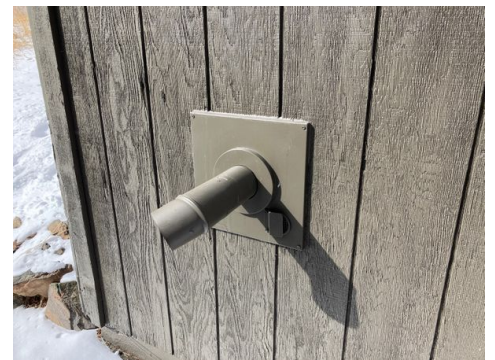
3.14.1 Vents

INCORRECTLY VENTED

Recommendation
Contact a qualified professional.

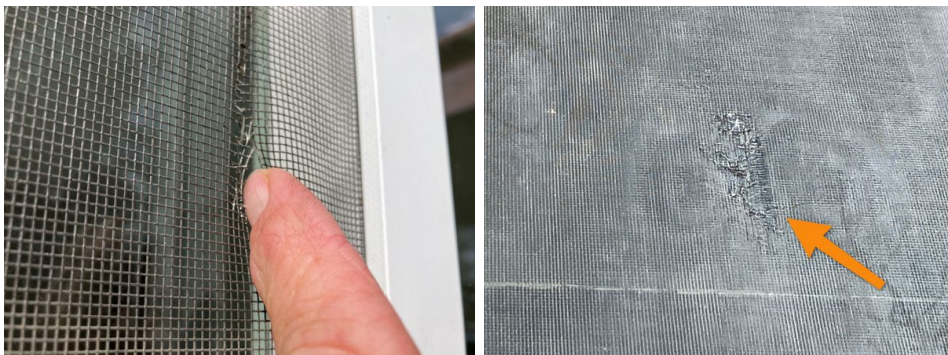
3.15.1 Windows

DAMAGED SCREEN

One or more screens were damaged. A qualified contractor should repair or replace.

Recommendation
Contact a qualified professional.

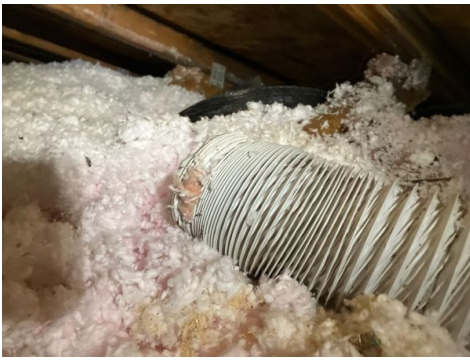
4.3.1 Exhaust Systems

BATHROOM VENTS INTO ATTIC

Bathroom fan vents into the attic, which can cause moisture and mold. Recommend a qualified attic contractor property install an exhaust to terminate to the exterior.

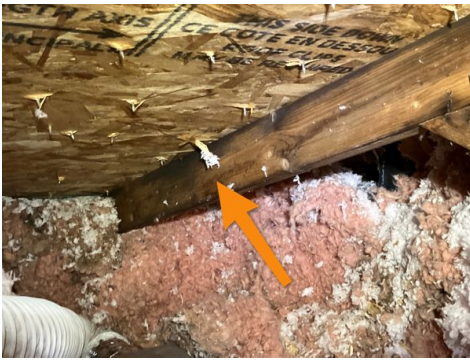
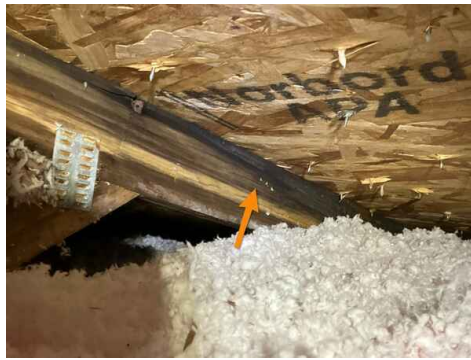
4.4.1 Structure

WATER INTRUSION

Water intrusion was present on the rafters. The likely cause was ice damming from a previous roof; the roof decking did not appear damaged and was likely replaced with one of the previous roofs.

Contact a qualified professional.

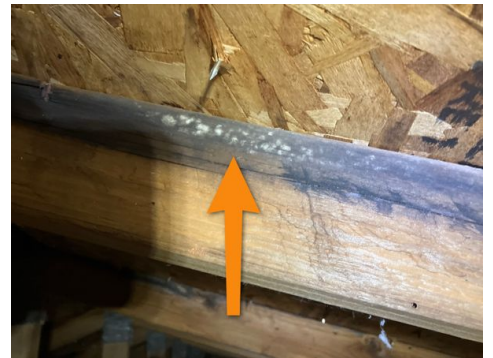
4.4.2 Structure

POSSIBLE MOLD

Possible mold was observed on a rafter and damage was notice in other areas of the attic. The wood and area were dry and appeared to be damage from a previous roof. Recommend asking the sellers about the previous condition.

Contact a qualified professional.

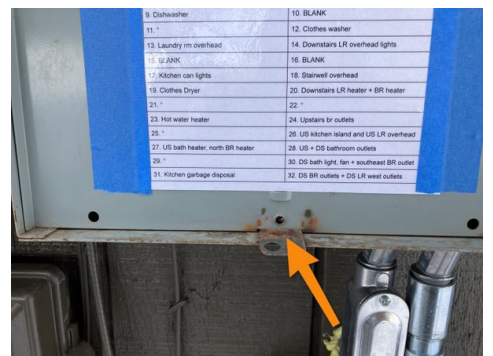
5.2.1 Main & Subpanels, Service & Grounding, Main Overcurrent Device

SCREW MISSING

The faceplate of the panel was missing a screw to keep it secure. A qualified contractor should replace.

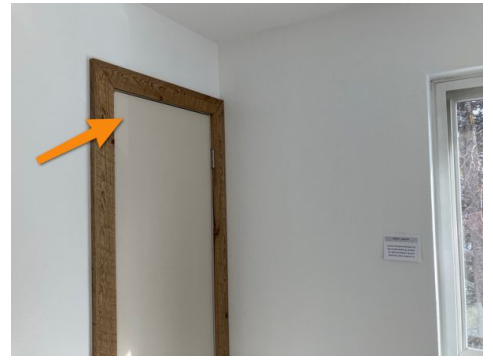
6.1.1 Doors

RUBS FRAME

The door rubs the frame when opening and closing. This may mean the door or frame is out of square or that the hinges may not have been installed properly and need adjustment. A qualified contractor should evaluate and repair or replace.

Contact a qualified professional.

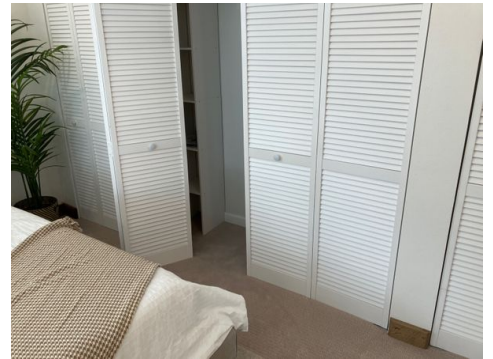
6.1.2 Doors

DOESN'T OPERATE SMOOTHLY

Contact a qualified professional.

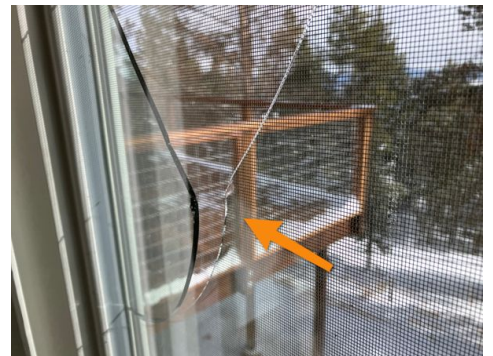
6.2.1 Windows

GLASS BROKEN/CRACKED

The window had a cracked or broken glass pane. A qualified contractor should evaluate and repair or replace.

Contact a qualified professional.

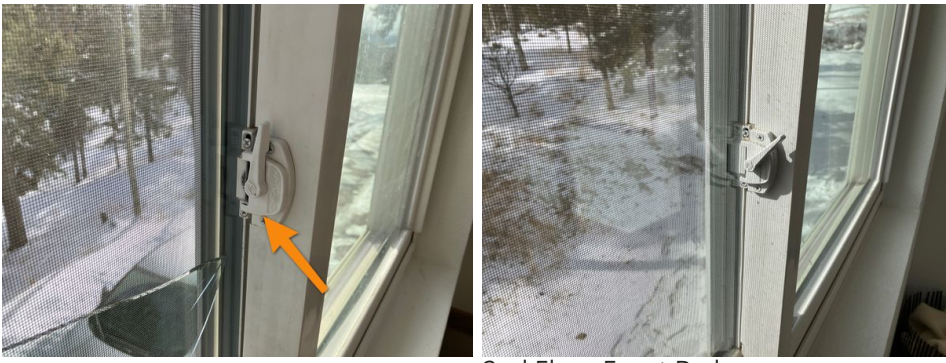
6.2.2 Windows

LOCK DAMAGED OR MISSING

The window had a damaged or missing lock; these windows would not lock. A qualified contractor should evaluate and repair or replace.

Contact a qualified professional.

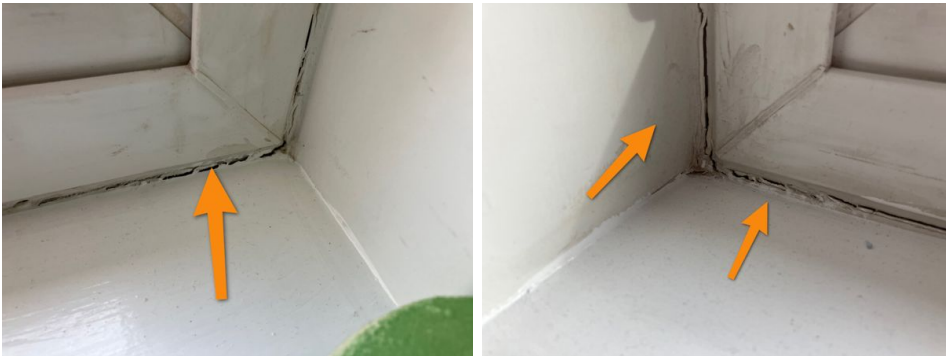
6.2.3 Windows

SEALANT DAMAGE AROUND FRAME

The sealant was damaged, deteriorated or otherwise insufficient around some of the windows. This can allow air and or moisture intrusion through the damaged areas. A qualified contractor should evaluate and repair or replace.

Contact a qualified professional.

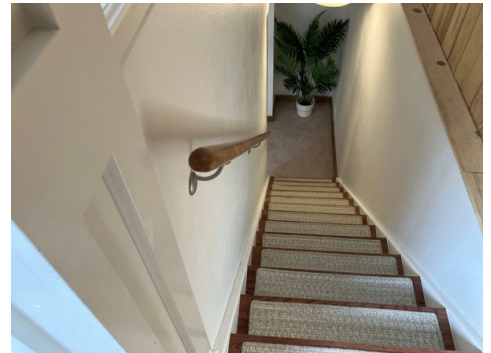
6.7.1 Steps, Stairways & Railings

NOT CONTINUS

The hand rail did not terminate at the wall. A bag, purse or coat could catch on the end of the rail and could cause a fall. A qualified contractor should evaluate and repair or replace.

Contact a qualified professional.

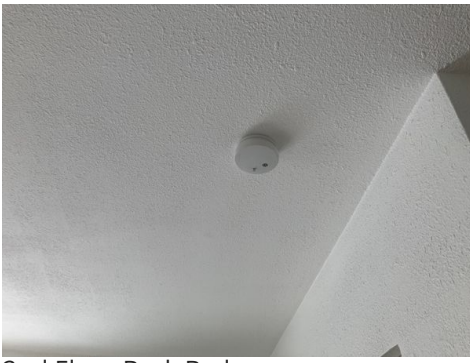
6.8.1 Smoke & CO Detectors

NOT WORKING

All detectors were not in working order. This could mean they need battery replacement or the unit needs replaced.

Contact a qualified professional.

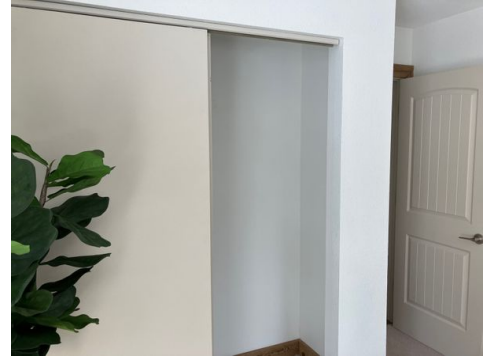
6.10.1 Closets

NO HARDWARE

The closet did not have shelving or a clothes rod.

Contact a qualified professional.

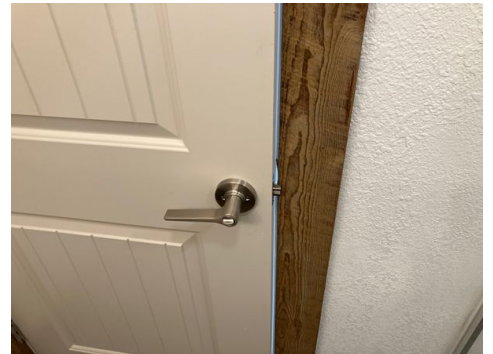
7.1.1 Doors

RUBS FRAME

The door is rubbing the frame and could be a hinge or strike plate adjustment. A qualified contractor should evaluate and repair or replace.

Contact a qualified professional.

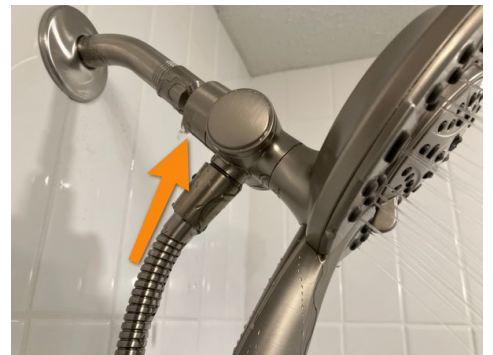
7.10.1 Plumbing

LEAKS AT THE SHOWER HEAD

The shower head was leaking. A qualified contractor should evaluate and repair or replace.

Contact a qualified professional.

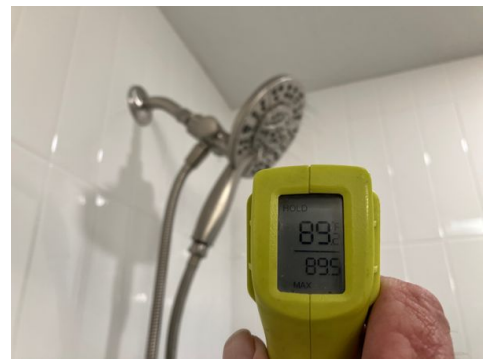
7.11.1 Water Temperature

LOW TEMPERATURE

The water temperature is below the recommended level of 120-130 degrees. The water heater temperature gauge may need to be adjusted.

Recommendation
Contact a qualified professional.

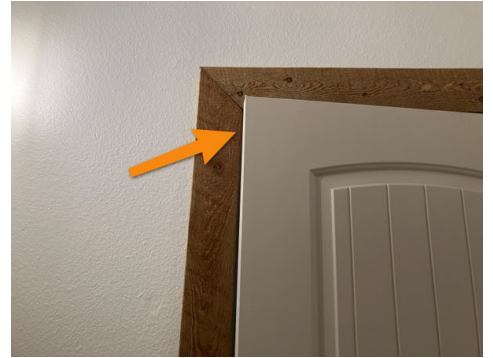
8.1.1 Doors

DOESN'T CLOSE

The door is hitting the frame and would not close. A qualified contractor may be able to make hinge or jamb adjustments.

Recommendation
Contact a qualified professional.

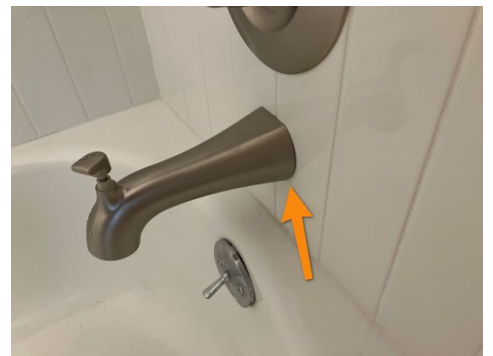
8.9.1 Plumbing

SEAL TUB SPOUT

The tub spout should be sealed to keep water intrusion out of the wall. A qualified contractor should evaluate and repair or replace.

Recommendation
Contact a qualified professional.

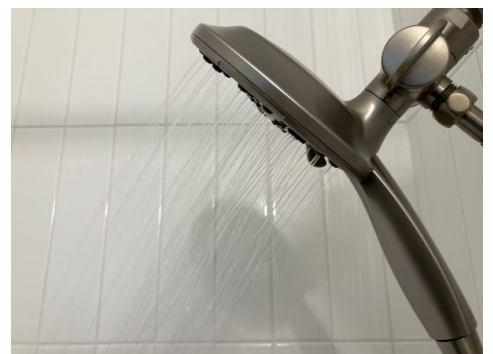
8.9.2 Plumbing

LOW PRESSURE

The pressure flow was low from the shower head. A qualified contractor should evaluate and repair or replace.

Recommendation
Contact a qualified professional.

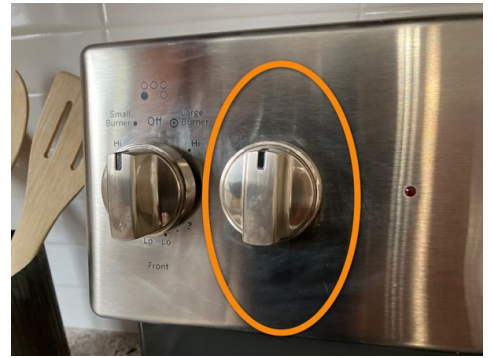
9.6.1 Range/Oven/Cooktop
DISPLAY DAMAGED

The display at the stovetop knobs were eligible.

Recommendation
Contact a qualified professional.

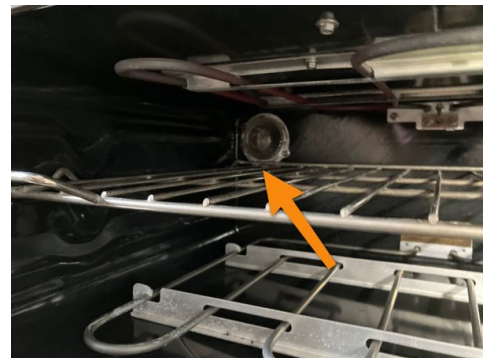
9.6.2 Range/Oven/Cooktop
OVEN LIGHT

The oven light was not working.

Recommendation
Contact a qualified professional.

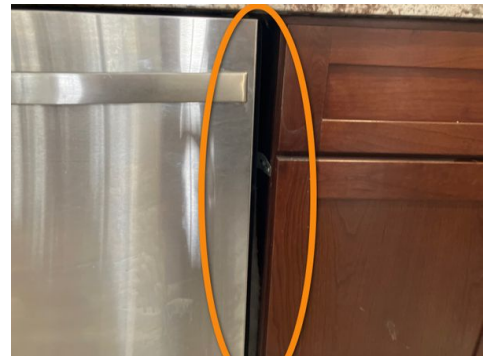
9.10.1 Countertops & Cabinets
MISSING TRIM

Trim on both sides of the dish machine was missing. A qualified contractor should evaluate and install.

Recommendation
Contact a qualified professional.

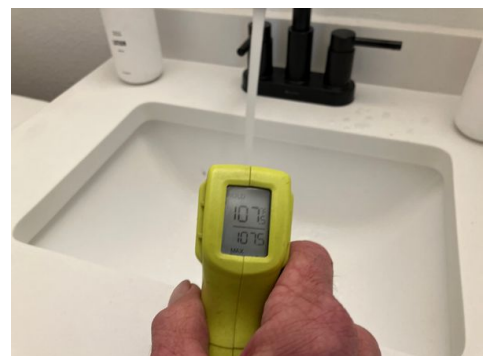
10.1.1 Hot Water Systems, Controls, Flues & Vents
LOW TEMP

Temperature coming from the faucets was low and should be increased to a comfortable temperature.

Recommendation
Contact a qualified professional.

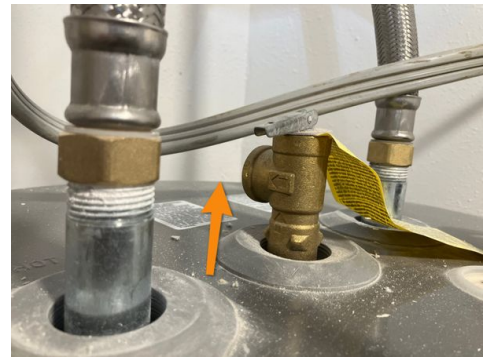
MISSING TPR VALVE PIPE

The valve was missing and could pose a burn hazard. A qualified contractor should evaluate and install.

Contact a qualified professional.

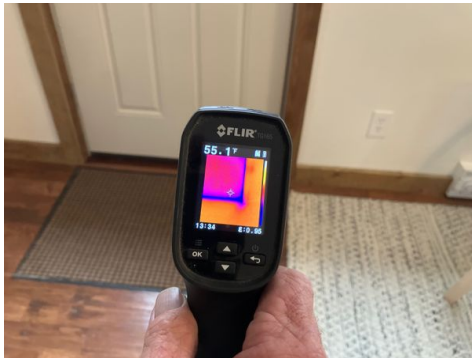
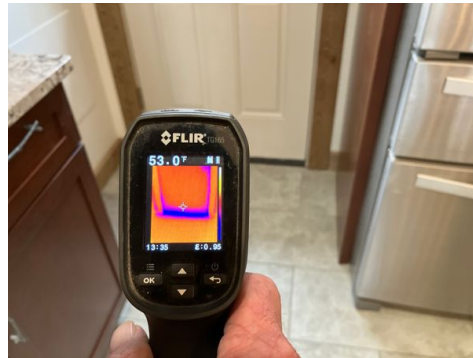
INSULATION, MOISTURE OR WEATHERSTRIPPING DAMAGED

Contact a qualified professional.
