INTEGRATED HOME AND ENVIRONMENTAL INSPECTIONS

RESIDENTIAL REPORT

11544 Green Ct
Conifer, CO 80433

FEBRUARY 23, 2023

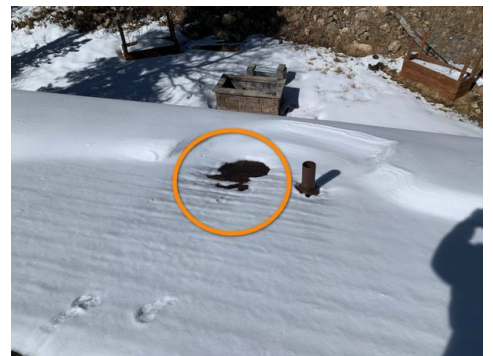
2.1.1 Coverings
UNEVEN MELTING

In the attic below this area, insulation is lacking and should be replaced once the bathroom fan has been addressed. The lack of insulation is also introducing warm air into the attic and has the potential to condensate and create moisture issues. Recommend adding insulation to fill the gap.

Contact a qualified professional.

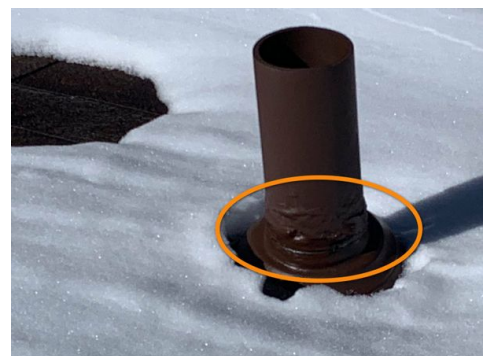
2.4.1 Skylights, Chimneys & Other Roof Penetrations

RUBBER BOOT DAMAGED

One or more vent boot was not installed properly or was damaged; the boot is beginning to deteriorate and should be replaced with the next roof. This condition could allow moisture intrusion into the roof system; recommend a sealant where the boot holds the pipe. A qualified contractor should evaluate and repair or replace.

Contact a qualified professional.

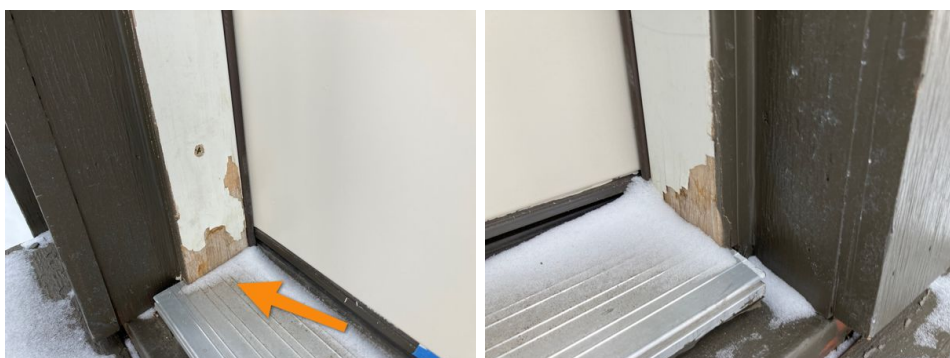
3.2.1 Siding, Flashing & Trim

Areas of siding or trim were worn and in need of maintenance. Recommend a qualified painter touch up the areas in need.

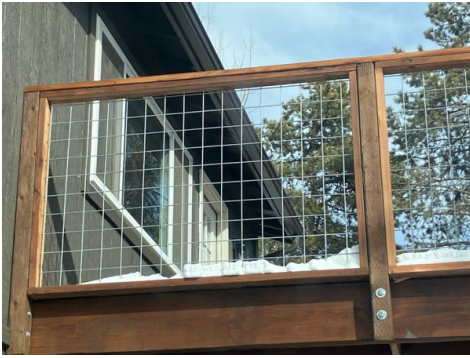
3.4.1 Decks, Balconies, Porches & Steps

HORIZONTAL RAILING

These types of railing are child safety hazards. Recommend either changing the rails to vertical only or not allowing children to play on the deck without supervision.

Contact a qualified professional.

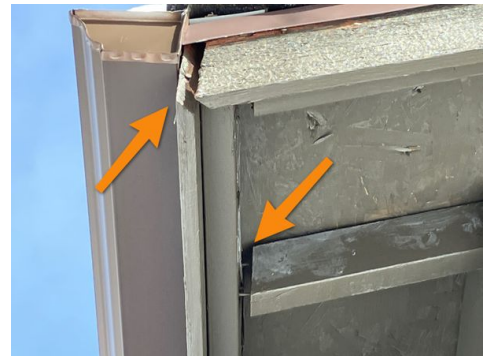
3.5.1 Eaves, Soffits & Fascia

FASCIA - LOOSE

One or more sections of the fascia are loose. Recommend qualified roofer evaluate & repair.

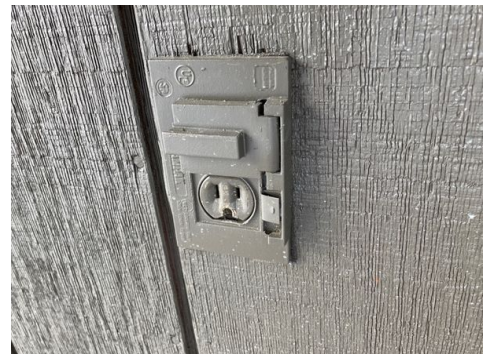
3.6.1 Lighting Fixtures, Switches & Receptacles

COVER PLATES MISSING

One or more receptacles are missing a cover plate. This causes short and shock risk. Recommend installation of plates.

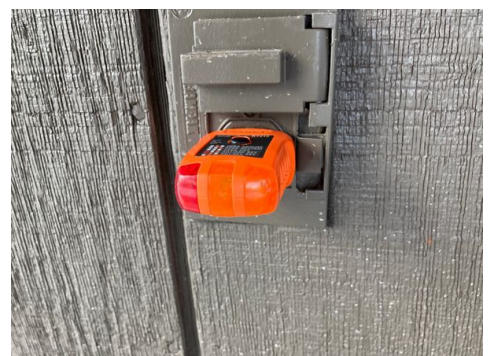
3.6.2 Lighting Fixtures, Switches & Receptacles

NO GFCI PROTECTION

Contact a qualified professional.

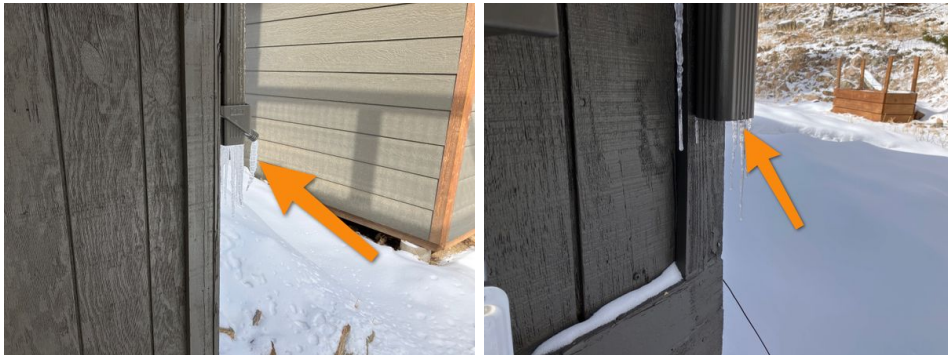
MISSING EXTENSIONS

The downspouts are missing extensions. These are necessary to keep water away from the foundation of the house. A qualified contractor should install extensions to shed water at least 6 feet away from the house.

Contact a qualified professional.

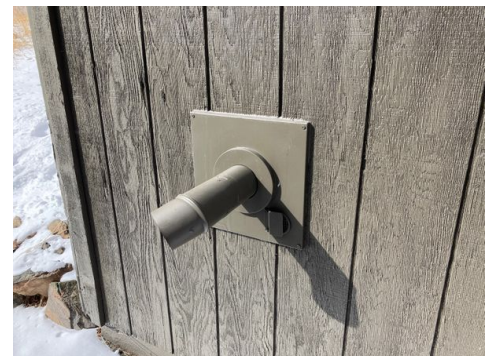
3.14.1 Vents

INCORRECTLY VENTED

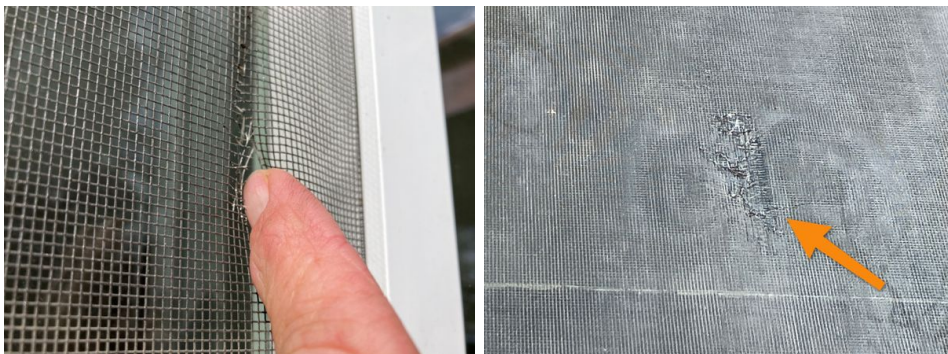
3.15.1 Windows

DAMAGED SCREEN

One or more screens were damaged. A qualified contractor should repair or replace.

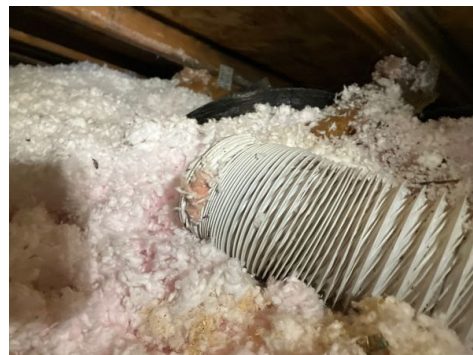
4.3.1 Exhaust Systems

Bathroom fan vents into the attic, which can cause moisture and mold. Recommend a qualified attic contractor properly install an exhaust to terminate to the exterior.

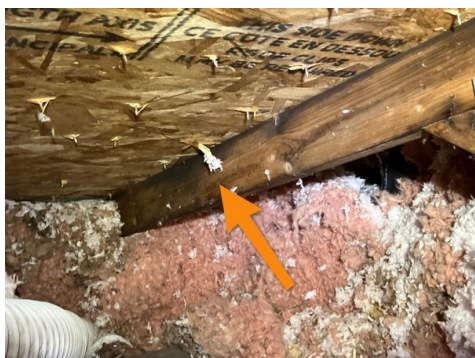
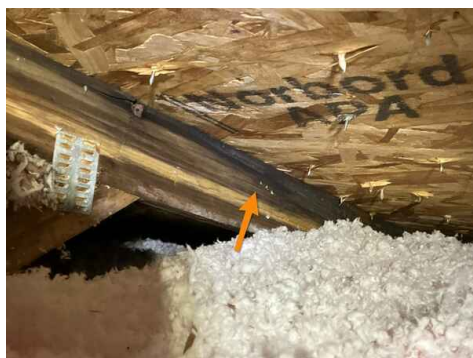
4.4.1 Structure

Water intrusion was present on the rafters. The likely cause was ice damming from a previous roof; the roof decking did not appear damaged and was likely replaced with one of the previous roofs.

Contact a qualified professional.

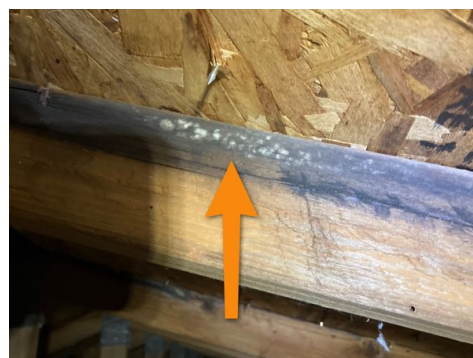
4.4.2 Structure

Possible mold was observed on a rafter and damage was noticed in other areas of the attic. The wood and area were dry and appeared to be damage from a previous roof. Recommend asking the sellers about the previous condition.

Contact a qualified professional.

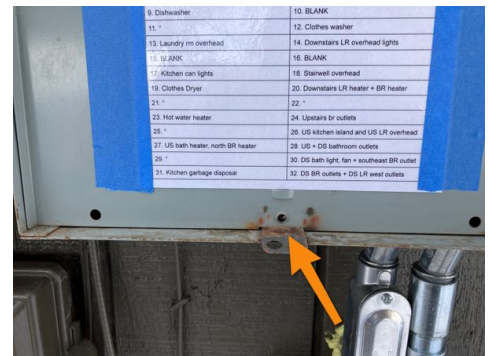
5.2.1 Main & Subpanels, Service & Grounding,
Main Overcurrent Device

SCREW MISSING

The faceplate of the panel was missing a screw to keep it secure. A qualified contractor should replace.

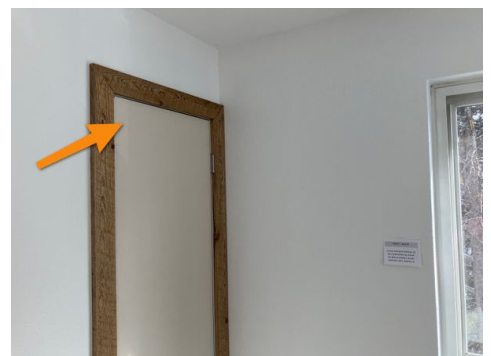
6.1.1 Doors

The door rubs the frame when opening and closing. This may mean the door or frame is out of square or that the hinges may not have been installed properly and need adjustment. A qualified contractor should evaluate and repair or replace.

Contact a qualified professional.

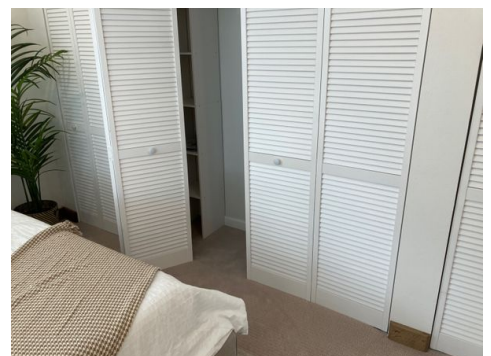
6.1.2 Doors

DOESN'T OPERATE SMOOTHLY

Contact a qualified professional.

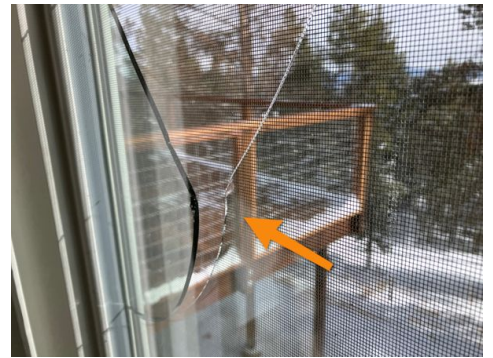
6.2.1 Windows

GLASS BROKEN/CRACKED

The window had a cracked or broken glass pane. A qualified contractor should evaluate and repair or replace.

Contact a qualified professional.

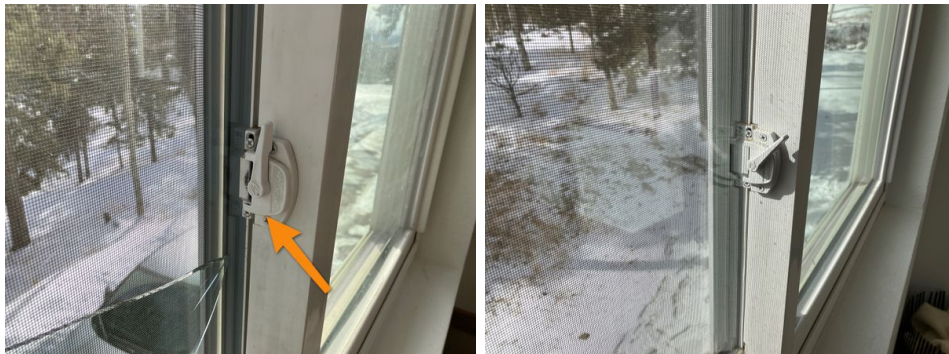
6.2.2 Windows

LOCK DAMAGED OR MISSING

The window had a damaged or missing lock; these windows would not lock. A qualified contractor should evaluate and repair or replace.

Contact a qualified professional.

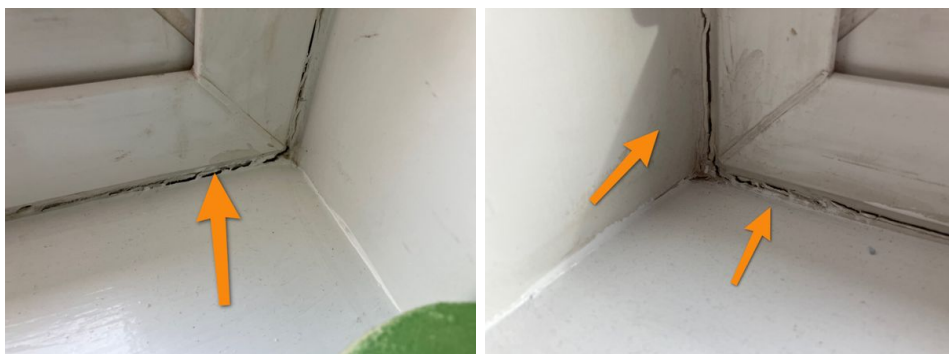
6.2.3 Windows

SEALANT DAMAGE AROUND FRAME

The sealant was damaged, deteriorated or otherwise insufficient around some of the windows. This can allow air and or moisture intrusion through the damaged areas. A qualified contractor should evaluate and repair or replace.

Contact a qualified professional.

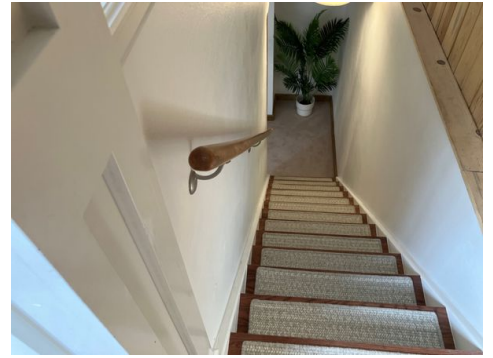
6.7.1 Steps, Stairways & Railings

NOT CONTINUS

The hand rail did not terminate at the wall. A bag, purse or coat could catch on the end of the rail and could cause a fall. A qualified contractor should evaluate and repair or replace.

Contact a qualified professional.

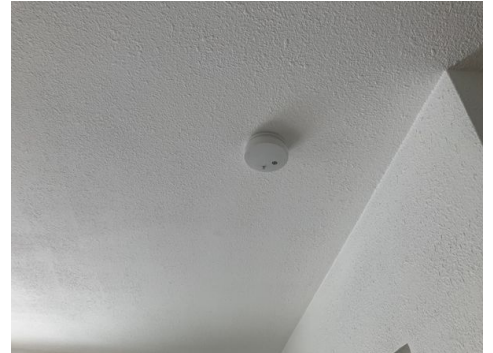
6.8.1 Smoke & CO Detectors

NOT WORKING

All detectors were not in working order. This could mean they need battery replacement or the unit needs replaced.

Contact a qualified professional.

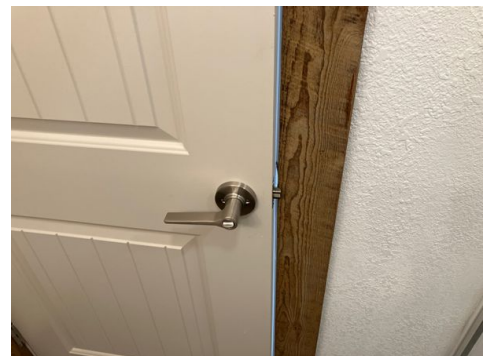
7.1.1 Doors

The door is rubbing the frame and could be a hinge or strike plate adjustment. A qualified contractor should evaluate and repair or replace.

Contact a qualified professional.

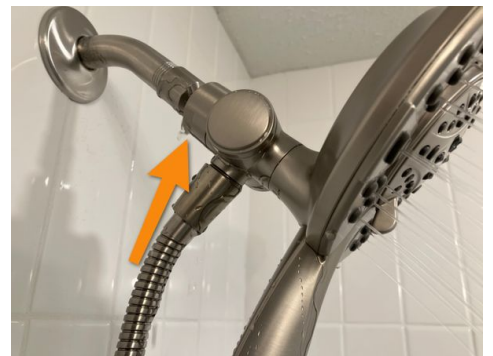
7.10.1 Plumbing

LEAKS AT THE SHOWER HEAD

The shower head was leaking. A qualified contractor should evaluate and repair or replace.

Contact a qualified professional.

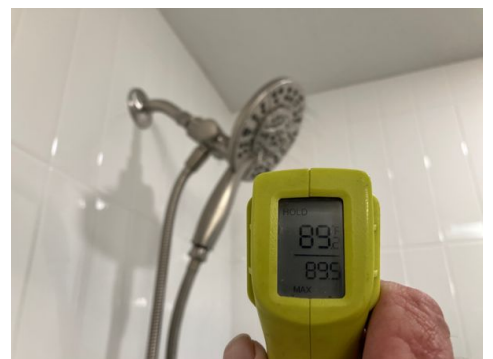
7.11.1 Water Temperature

The water temperature is below the recommended level of 120-130 degrees. The water heater temperature gauge may need to be adjusted.

Contact a qualified professional.

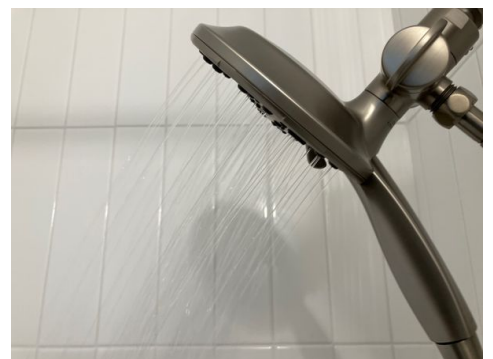
8.9.2 Plumbing

The pressure flow was low from the shower head. A qualified contractor should evaluate and repair or replace.

Contact a qualified professional.

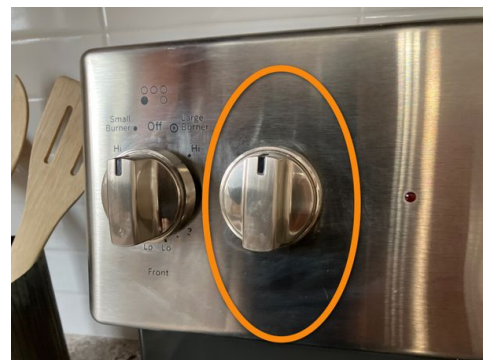
9.6.1 Range/Oven/Cooktop

DISPLAY DAMAGED

Contact a qualified professional.

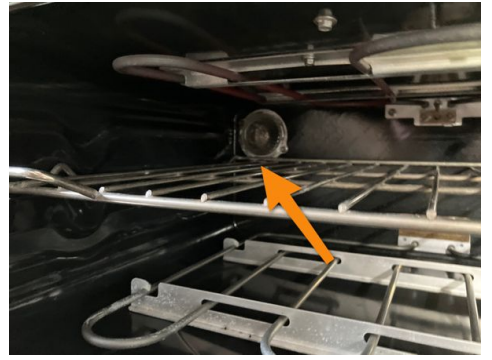
9.6.2 Range/Oven/Cooktop

OVEN LIGHT

Contact a qualified professional.

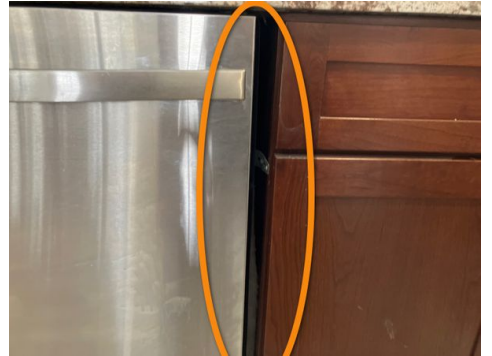
9.10.1 Countertops & Cabinets

MISSING TRIM

Trim on both sides of the dish machine was missing. A qualified contractor should evaluate and install.

Contact a qualified professional.

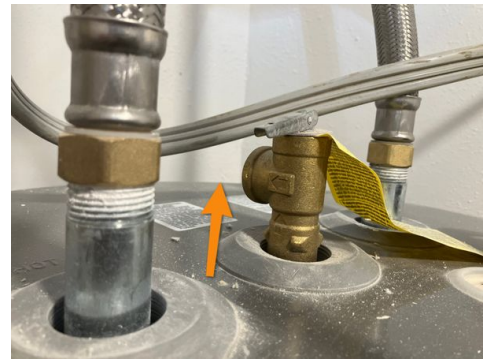
10.1.2 Hot Water Systems, Controls, Flues & Vents

MISSING TPR VALVE PIPE

The valve was missing and could pose a burn hazard. A qualified contractor should evaluate and install.

Contact a qualified professional.

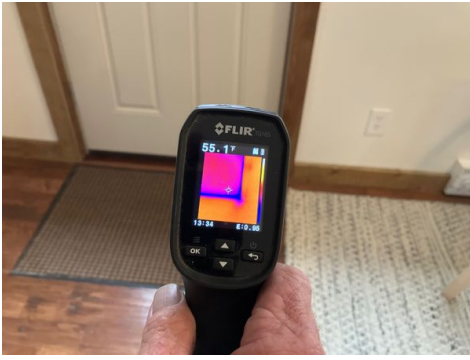
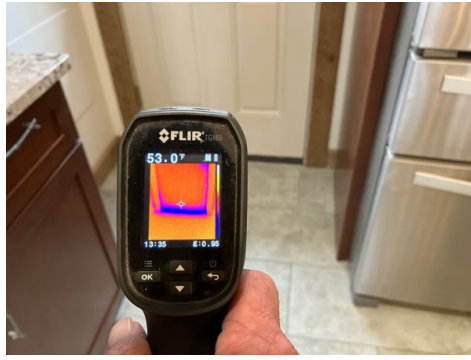
13.1.1 Inspected

INSULATION, MOISTURE OR WEATHERSTRIPPING DAMAGED
